KAIKOURA EMERGENCY RESPONSE AND RECOVERY – HOW RESILIENT IS YOUR WASTEWATER SYSTEM

Rob Potts^{a, c}

^a Lowe Environmental Impact Ltd, P O Box 29-288, Riccarton, Christchurch 8440;

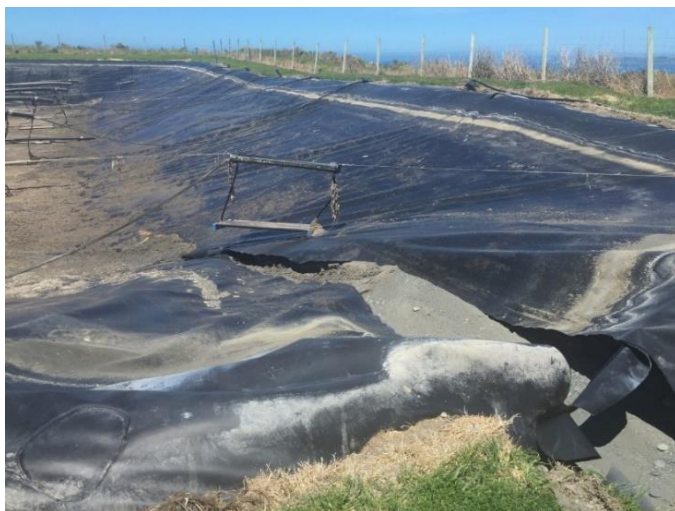
1. The concrete foundation slab for the inlet screen of the WWTP moved and settled during the earthquake. The screen shifted and the pipe connections broke, thereby disabling the inlet screen operation;
2. The aerated lagoon suffered the following damage as a result of an earthquake induced landslip:
 - A landslip extends the full length of the pond resulting in tearing to the liner and the draining of the pond (see Figure 1);
 - A graben approximately 8 – 10 m in width has formed extending through the pond with approximately 500 mm of vertical deformation;
 - A toe bulge was identified at stream level to the south of the lagoon approximately 8 m below the crest of the pond;

- Multiple tension cracks were observed on the eastern, western and southern embankments;
 - Movement from the landslip is predominantly in a southerly direction but some movement occurred towards the south west;

- Fencing around the pond has been deformed;
 - The damage to the lagoon has made it inoperable. All wastewater sitting in the aerated lagoon prior to the earthquake has drained into the sea and the lagoon is now empty. The aerated lagoon is temporarily being bypassed, with the screened influent and the septage going directly into the oxidation pond;

Figure 1: Damaged Aerated Lagoon

- Repair the existing aerated lagoon in the current location but with embankment toe support to stop it collapsing into the creek in another quake;
- Replace the aerated lagoon with a new lagoon north of the existing oxidation pond; and
- Replace the entire WWTP with a membrane bioreactor (MBR).

An evaluation of the options including preliminary cost estimates determined that the most cost effective recovery is to build a new lagoon to the north of the existing oxidation pond and alter the pipework to allow flow to be transferred appropriately.

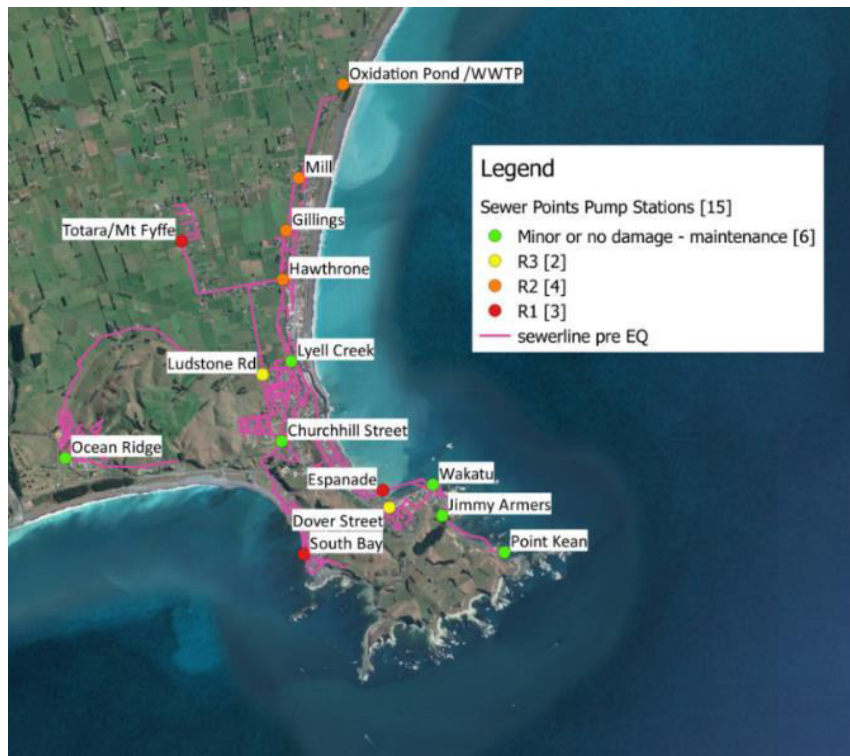
- Six of the 14 pumping stations received damage during the earthquake ranging from ground subsidence around the wet well to pipe failure and chamber concrete riser displacements (see colour coding in Figure 2 and Table 1, based on SCIRT).

Figure 2: Wastewater Infrastructure showing Pumps Stations

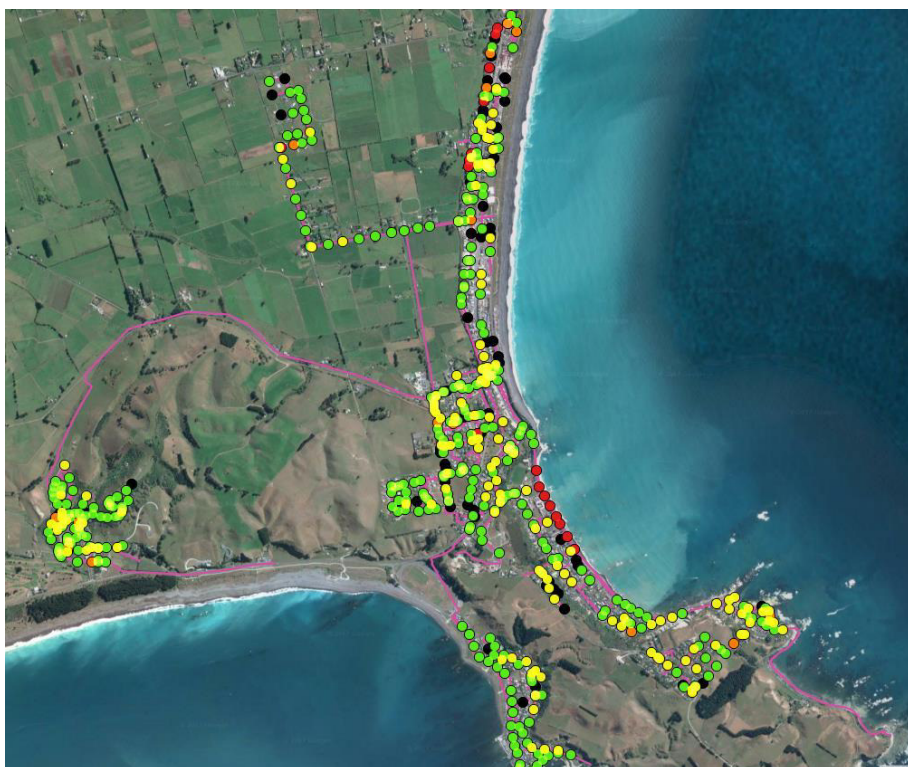
- The manholes inspection results have been split in structure issues, joints issues, water infiltration, no damage with and without maintenance needed, missing and general further assessment needed. In total, 109 (64 missing, 10 with joints issues, 29 with structural issues and 6 that require general further assessment) of the wastewater manholes require repair or replacement work, or further investigation - that is 20% of the manholes. See Figures' 3 and 4.

Figure 3: Wastewater Manhole Damage

It is recommended to repair 20 manholes and replace 19 manholes of the Kaikoura sewer network.

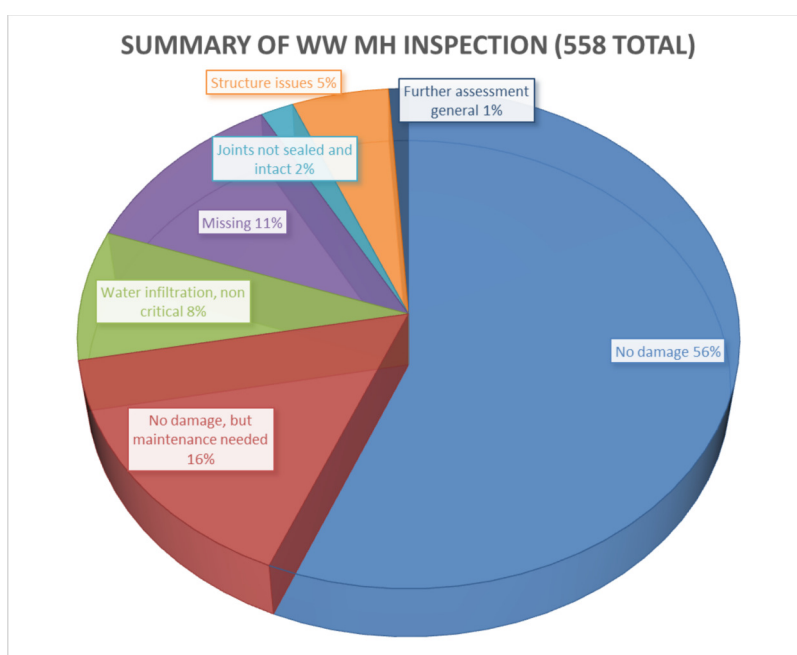
Figure 4: Wastewater MH Summary

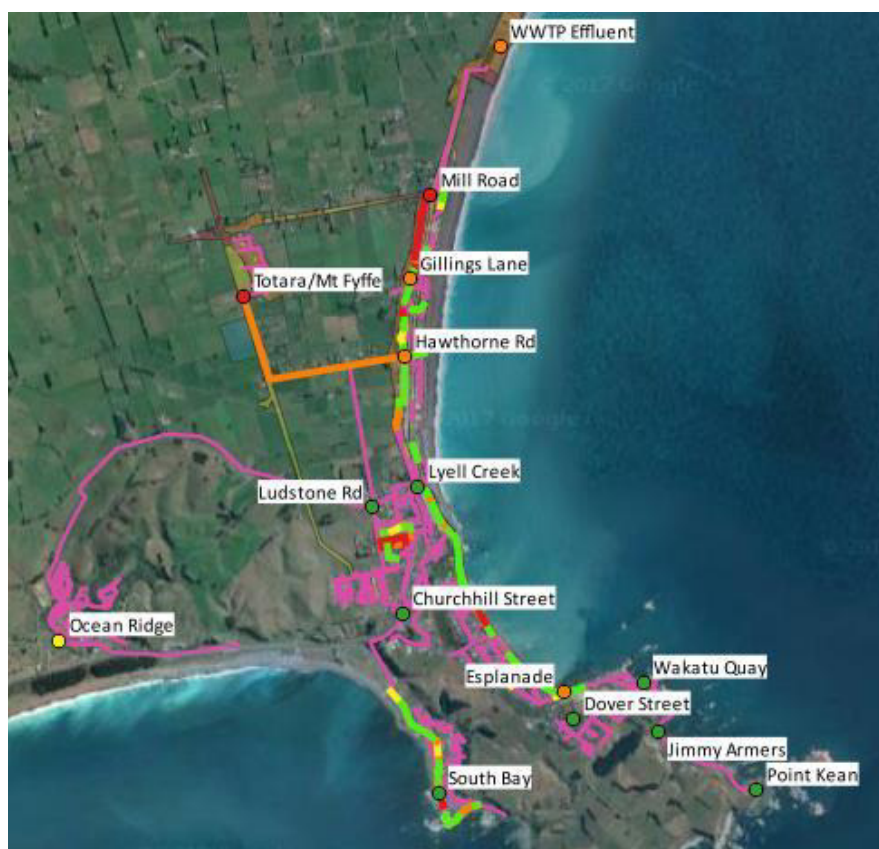
- CCTV survey assessments show 22 sections of 450 mm AC main damaged and requiring replacement (about 102 m). In addition, preliminary ground damage assessment hazard maps show wastewater pipelines in areas of high and medium

geotechnical hazard around: Mill Road and Mt Fyffe Road intersection and along Mill Road and Mt Fyffe Road; Mill Road pumping station and upstream along Lyell Creek, to Gillings Lane pumping station and Hawthorne Road pumping station, and further down along Lyell Creek to 47 Beach Road; and Esplanade along coastline (medium geotechnical hazard). The assessment is shown in Figures 5.

- 250 m of the 300 mm diameter main immediately upstream of the WWTP that runs through a boggy area was damaged and needs replacing.
- The Mt Fyffe / Totara Lane gravity main needs repairing in a number of places.

Figure 5: Reticulation Pipe Damage

1. Repair each damaged section and replace the broken pipe sections in-place without any additional measures put in place for future earthquake resilience (\$1,030,000);
2. Repair each damaged section and replace the broken pipe sections in-place with the addition of 4.8 m posts at 0.8 m centres to stop the pipe moving towards Lyell Creek from Lyell Creek to Mill Road to provide additional future earthquake resilience (\$7,510,000);
3. Relay the main sewer line on SH 1, leave the pump stations (PSs) where they are. Replace the damaged sewer along Lyell Creek with a smaller PE line to each PS (\$5,322,000); and
4. Relay the main sewer along SH 1, replacing the PSs and connect low lying properties to the main via a pressure sewer network or minor PSs (\$5,814,000).

In addition, 300 m of the main sewer upstream of the WWTP is to be replaced with a 300 mm diameter PE pipe (\$189,000). The Mt Fyffe to Totara Lane gravity main is to be repaired in a number of places (\$250,000), sections of the Ocean Ridge main (\$109,000) and sections of Esplanade main (\$315,000).

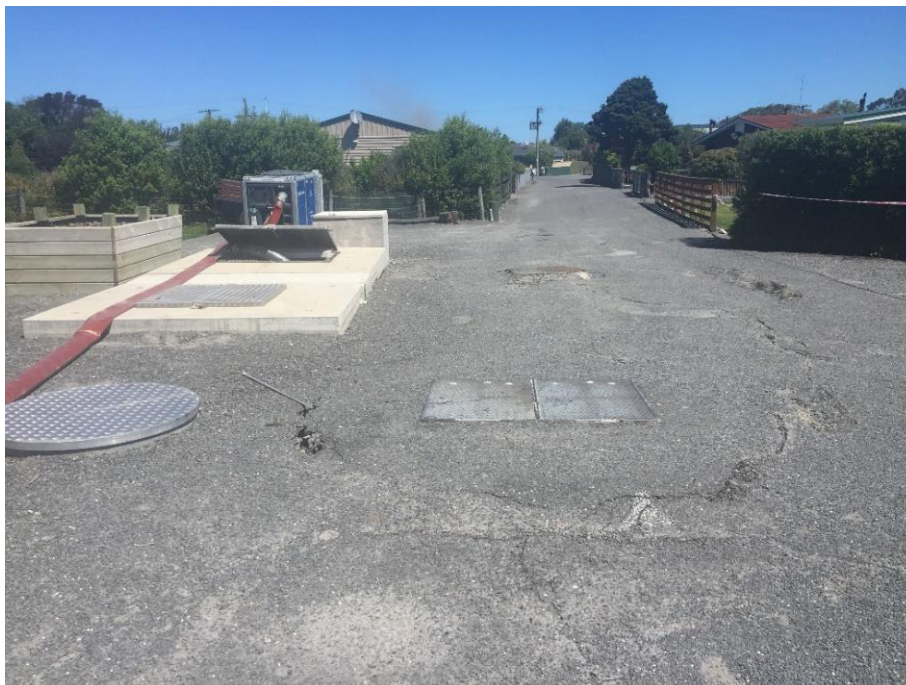
Figure 6: Temporary Trunk Pump Station

- The Aerated Lagoon was bypassed by attaching lay flat hose to the rising main, taking it over the now disused railway line, and direct to the oxidation pond. Later on, the step screen was reinstalled;
- Following the oxidation pond drop test, inlet and outlet pipework were inspected and disused pipes sealed or removed – this stopped the leakage from the pond;
- Installing portable diesel pumps at the main trunk main pump stations that were damaged;
- Fixing the pump stations that were not too badly damaged;
- Installing variable speed drives on the main pump stations to manage flows; and
- Running lay flat hoses to bypass damaged trunk main areas.

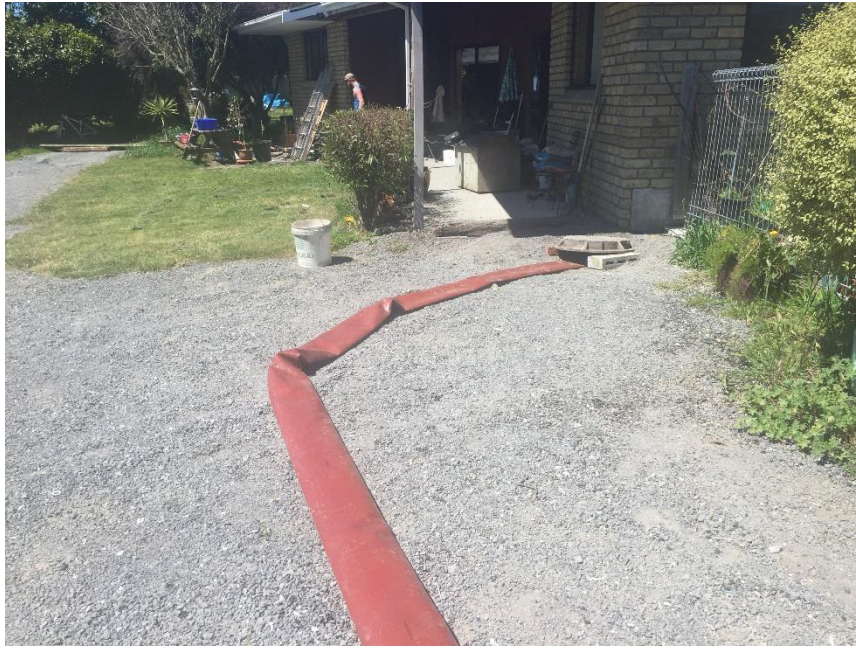
Figure 7: Temporary Rising Main

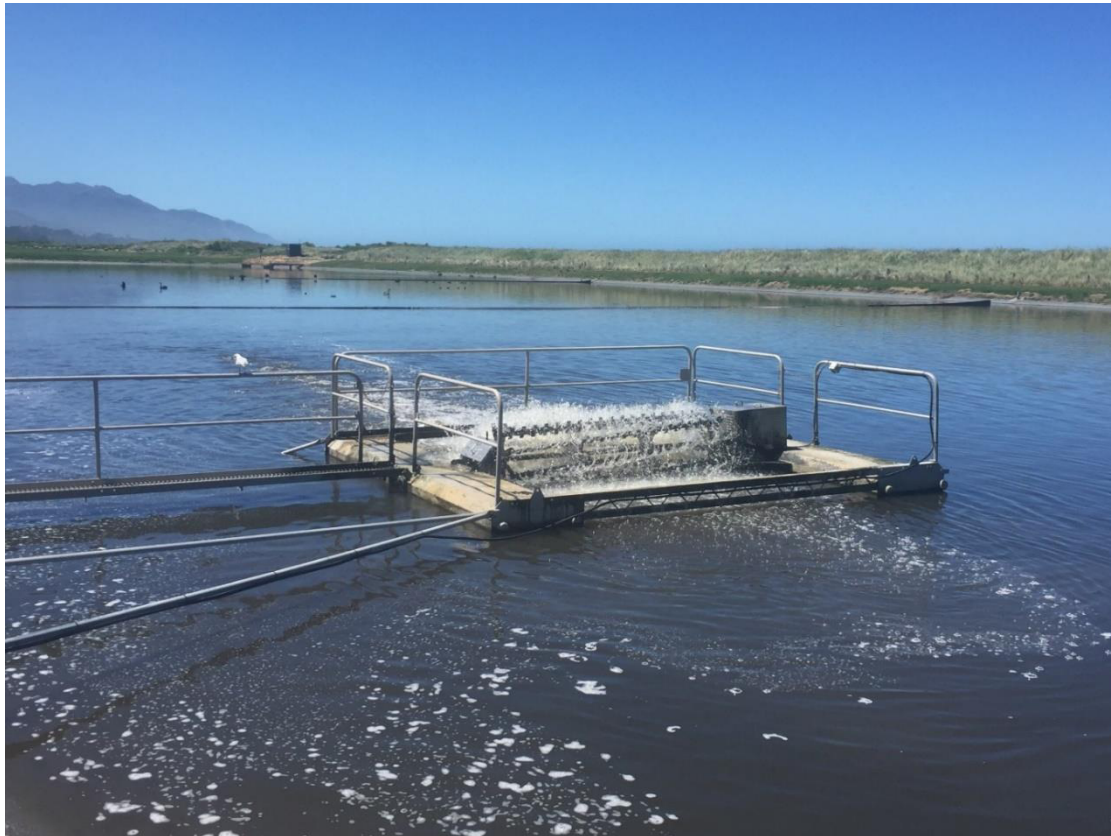
Although the oxidation pond did not appear damaged, its health did not look good soon after the earthquake. As can be seen in Figure 9 (8 days after the earthquake), there does not appear to be any algae in the pond. The reason for this was never known, as it was not possible to get pond samples away for analysis. Possible reasons are:

- a. the system was so overloaded due to the aerated lagoon being bypassed (unlikely as DO levels were taken and these were about 3 mg/L); and
- b. The system was underloaded. Due to there being no inputs for about 1 week, along with high I/I when the system was restarted (most likely).

Figure 9: Oxidation Pond Caged Rotor – no Algae

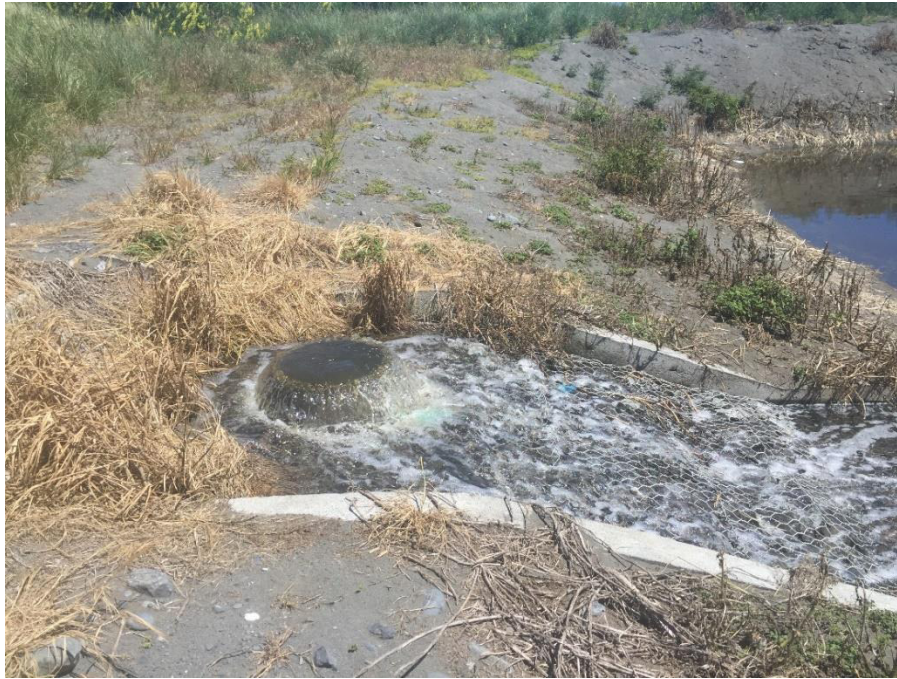
The land application system comprises of 4 rapid infiltration basins. These were constructed in the sand dunes to the north of the WWTP. Flow tests were conducted to each of the basins by measuring the height of discharge above the outlet and compared to the pump operating curve. The measurement showed that all the basins were receiving the design 35 L/s, with no pipe or fitting leakage. Figure 11 shows the discharge into one of the basins.

The infiltration rate through the basins has not been impacted on.

Figure 11: Infiltration Basin Inlet
