# **Wastewater Treatment and Land Treatment in Highly Variable Holiday Locations – Case Studies of two Queenstown Lakes Projects**

**Rob Potts<sup>a,d</sup>, Brent Hawthorn<sup>b</sup>, Melanie Heather<sup>c</sup>**

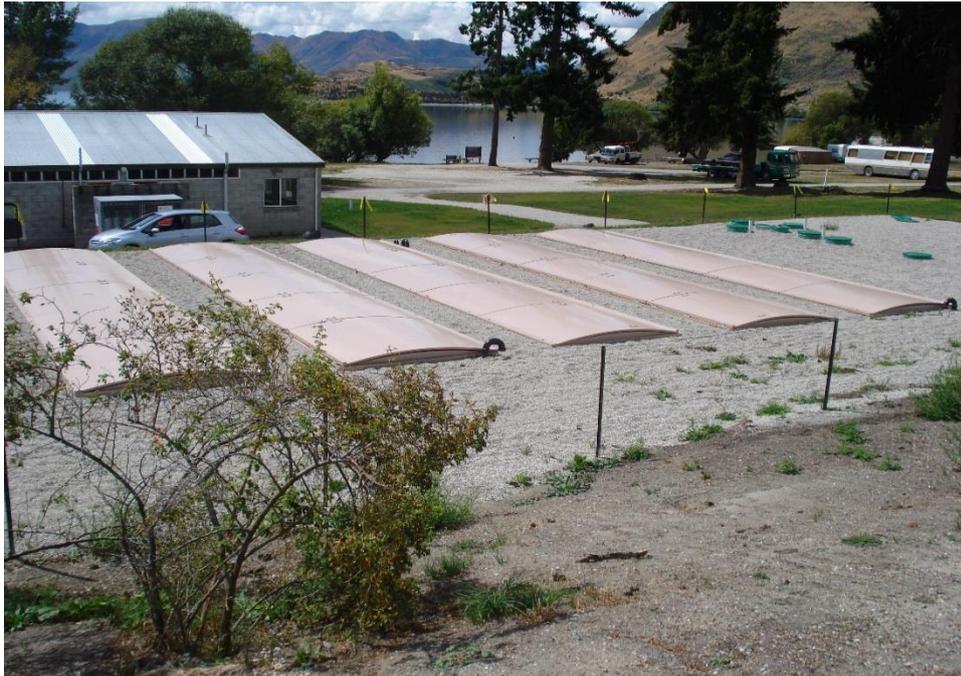
**Figure 1: Photo showing Completed System**

Innoflow replaced all but one of the existing septic tanks with new Septic Tank Effluent Pump (STEP) tanks and a small diameter effluent sewer reticulation network. Primary effluent, largely free of suspended solids and reduced BOD<sub>5</sub>, was pumped to a pre-anoxic zone followed by pre-aeration before aerobic treatment through a bank of four AdvanTex–MAX™ recirculating textile packed bed filters (as seen in Figure 1). A post-anoxic zone was installed to meet the TN limits and a fifth AdvanTex–MAX™ is used for polishing prior to ultraviolet light disinfection and irrigation. The land application system comprises 24 discharge control trenches, each 93 m long. Distribution pipes are buried at the depth of 350 mm to avoid damage as the entire area contains tent and caravan camp sites.

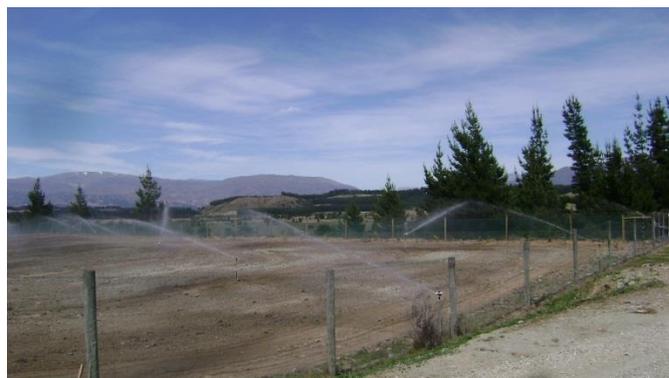
**Figure 3a: Sprinkler System**

The upgraded system utilises an upgraded disposal trench, with the overflow removed and a 2.33 ha land treatment area (LTA) using fixed sprinklers, as shown in Figure's 3a and 3b.

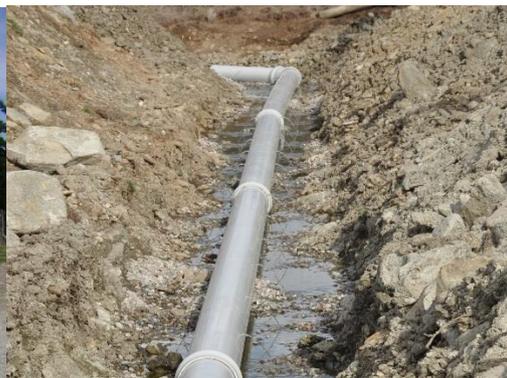
**Figure 3b: Trench System**
