Water quality improvement in the Waiwiri catchment through strategic establishment of native ecosystems with bioactive properties used at a land treatment site

Final report – January 2023

Report prepared for Freshwater Improvement Fund – Ministry for the Environment

Report number: FW23002

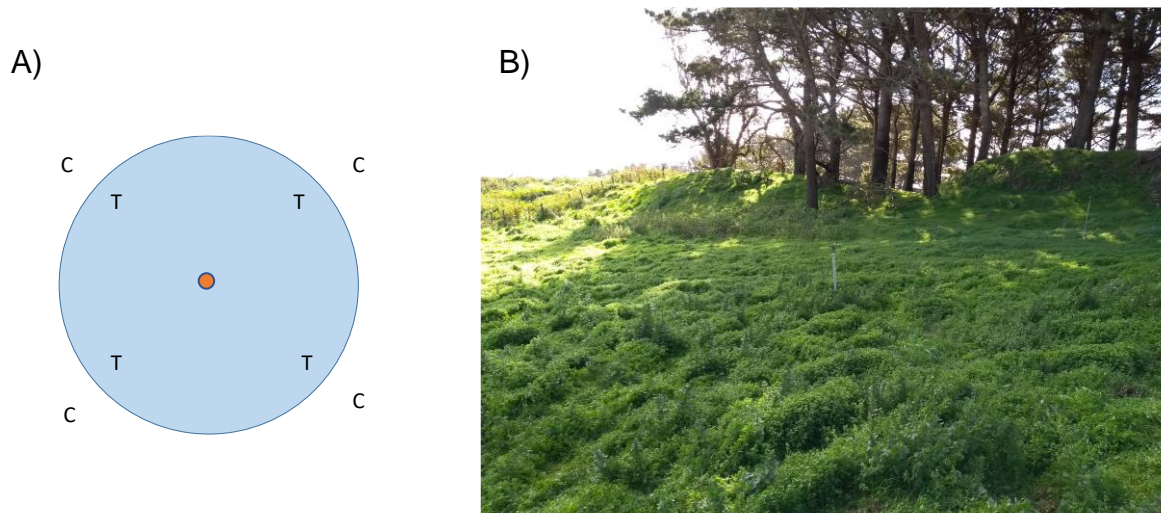
Figure 1 A) Experimental design of the preliminary trial, T: irrigated plants within the reach of the sprinkler, C: non-irrigated control plants; B) Photo of the sprinkler with surrounding plants.

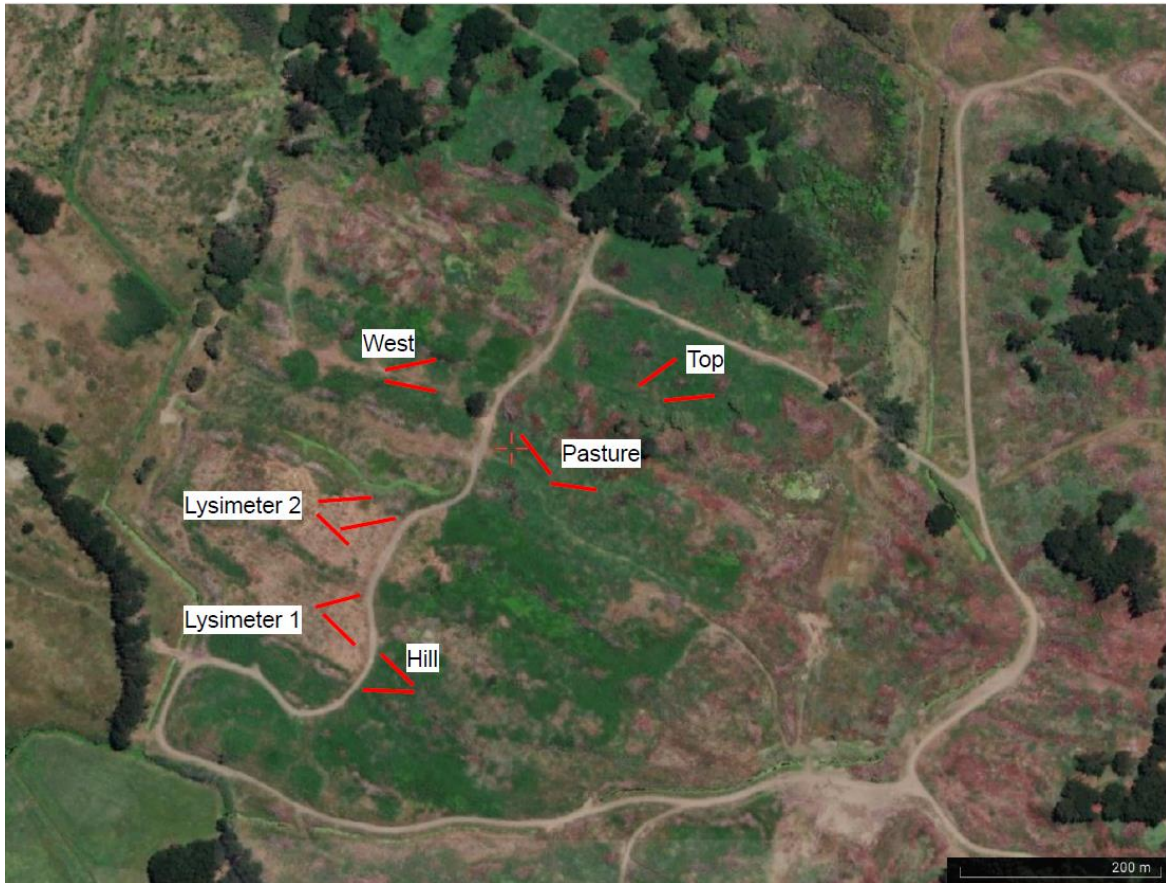
Figure 4 Location of transects recorded in May 2022 (red lines). The non-irrigated control area is next to the entrance and not shown here.

In May 2022, 60 transects were conducted, thereof 52 in six separate sections of the TMW-irrigated experimental area, and 8 outside of the experimental area in same-aged native vegetation without irrigation (Figure 4). In this monitoring campaign, the non-irrigated area sampled was located next to the main entrance gate to The Pot.

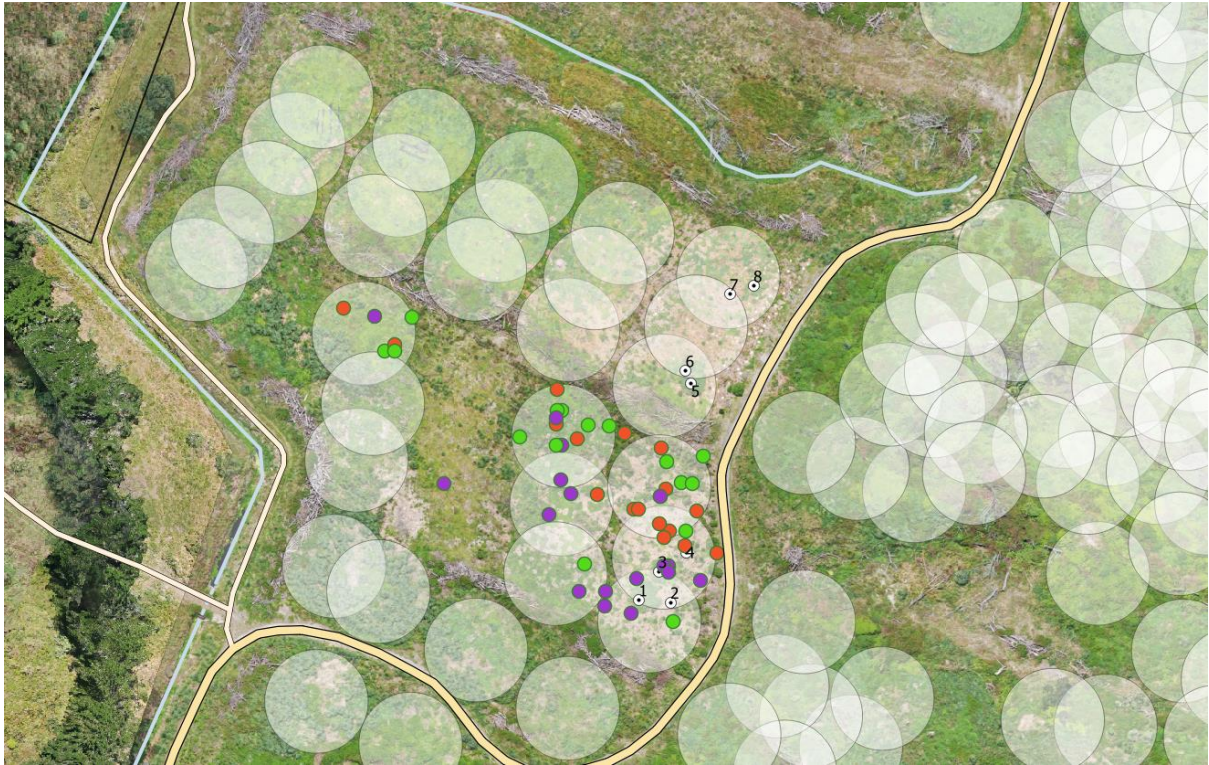
Figure 5 Aerial image showing the reach of the irrigation sprinklers in white circles, and sampling points in small red circles (mānuka), green circles (kānuka) and purple circles (pasture). Numbered points show the location of the Water Flux Meters (WFMs, Section 3.5).

In May 2019 eight Water Flux Meters (WFMs, Figure 8A) were installed in two TMW-irrigated flat areas at 10-20 m distance from the road. The exact locations are shown in Figure 5.

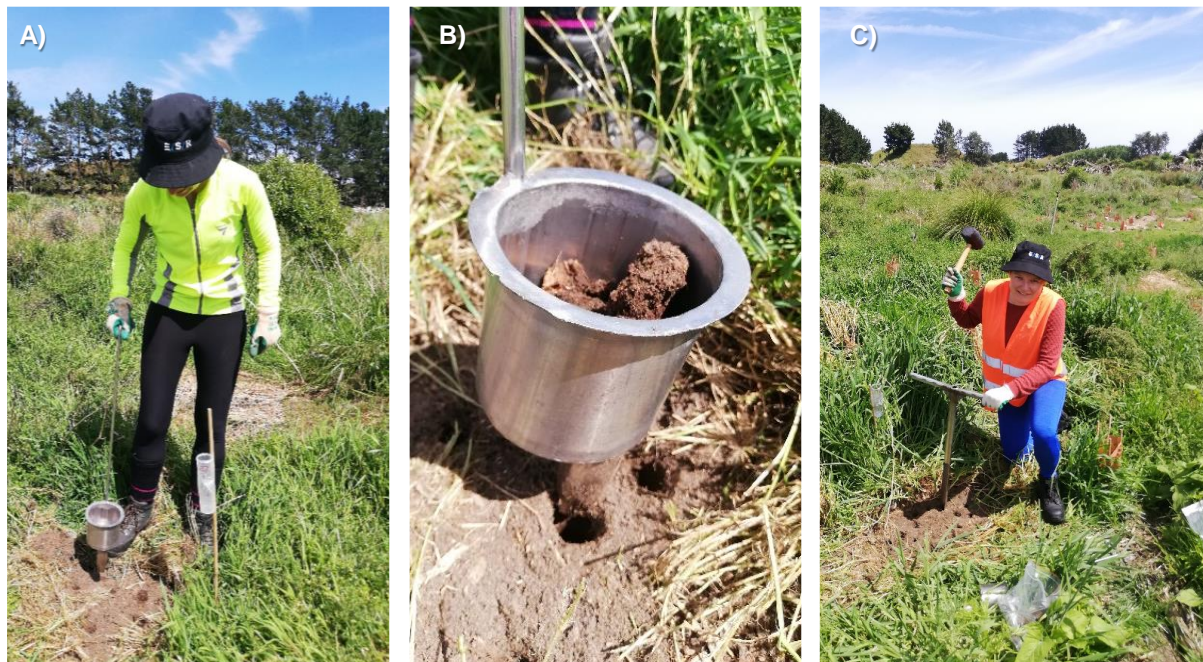
Figure 7 A) Collection of soil sample from the top soil (0-10 cm) with a bucket soil sampler; B) pooled sample in the bucket soil sampler; C) Collection of soil sample from the sub soil (30-45 cm) with a soil corer

Ten subsamples from the topsoil (0-10 cm) around the stem of each of the 17 mānuka and kānuka plants were collected with a bucket soil sampler and pooled into one sample (Figures 7A & B). A similar process was used to sample the topsoil under pasture cover in an area of approximately 0.25 m² after removing the vegetation cover. Soil from below the root systems (30-45 cm) was collected with a soil corer (Figure 7C) in the same areas where the topsoil was collected. Soil samples were transported to the laboratory in a chilly bin with icepacks and frozen at -20°C until further analysis.

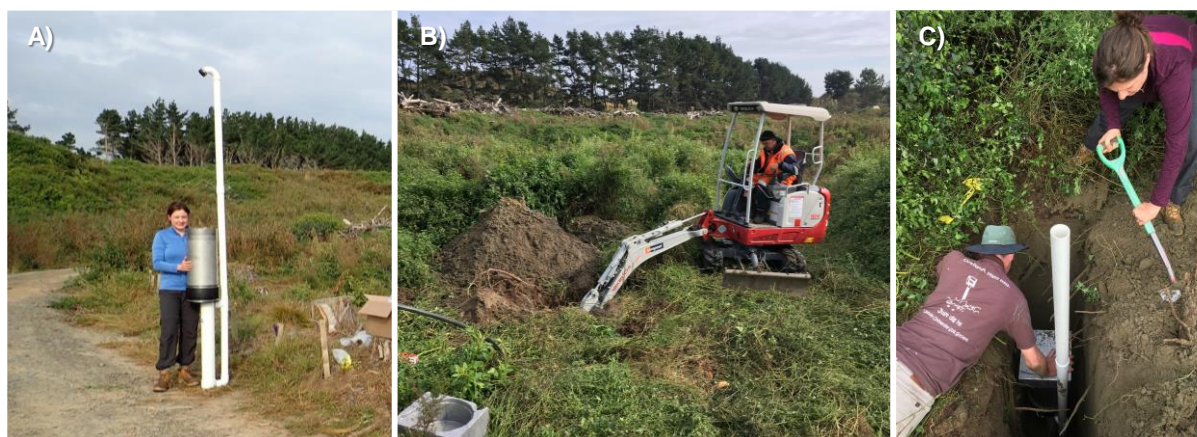
Figure 8 A) Water flux meter (WFM) ready for installation; B) Digging the trench for the installation of the WFM; C) installing the WFM.

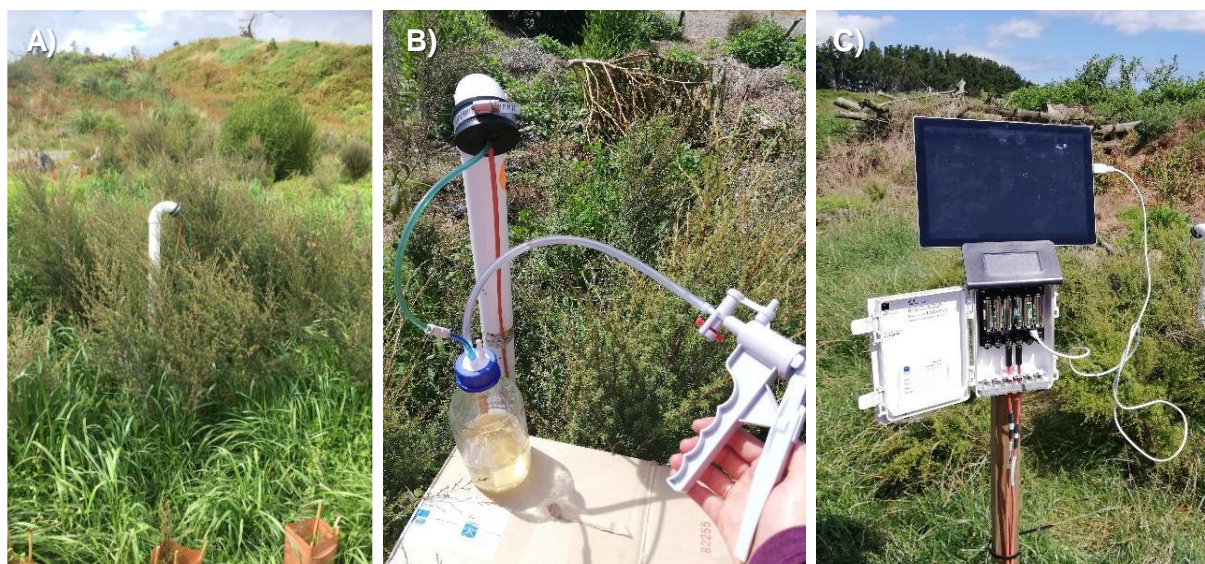
Figure 9 A) WFM with kānuka plants; B) Collecting leachate samples from the WFMs by handpump; C) Retrieving data from the data logger.

In August 2019, kānuka seedlings were densely planted (25 seedlings at 0.5 m spacing) on 2.5 x 2.5 m areas above four of the WFM (Figure 9A). The areas above the other four WFM was sown with a mixture of perennial ryegrass (*Lolium perenne*) and Yorkshire fog (*Holcus lanatus*). A similar seed mixture was applied around the kānuka seedlings and other areas of the experimental plots to prevent the germination of other weeds. The drainage in the WFM reservoirs was emptied by hand pump (Figure 9B). Four METER Environment® ZL6 data loggers were installed, and each was connected to two WFMs (Figure 9C). These data loggers allowed the collection of data on drainage volume, drainage electrical conductivity (EC), drainage temperature, and logger temperature.

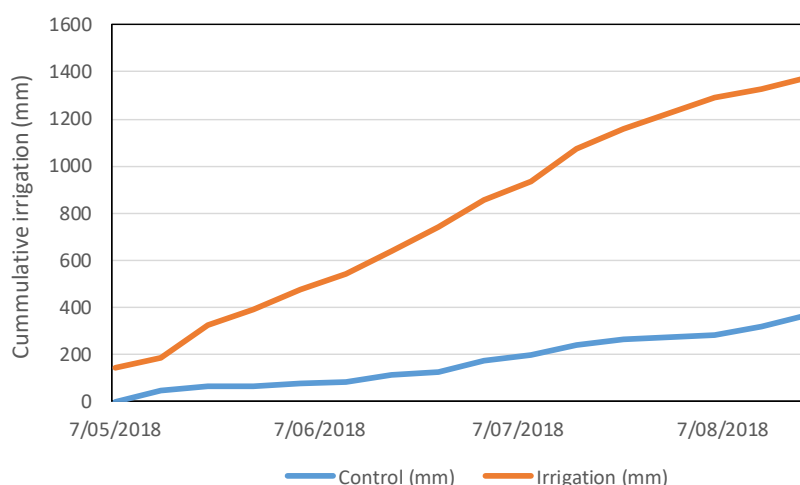
Figure 10 Cumulative rainfall (control) and TMW irrigation in the preliminary plant health trial.

Over the 15 weeks of the experiment, cumulative rainfall was 365 mm, and cumulative irrigation was 1008 mm (Figure 10). The irrigation was equivalent to an application rate of 3494 mm/yr, which was 25% lower than the average irrigation rate at The Pot. With an average nitrogen and phosphorus concentration in the TMW of 39 mg N/L and 5.6 mg P/L, respectively (Table 1), the application of those nutrients was equivalent to 393 kg N/ha and 56 kg P/ha.

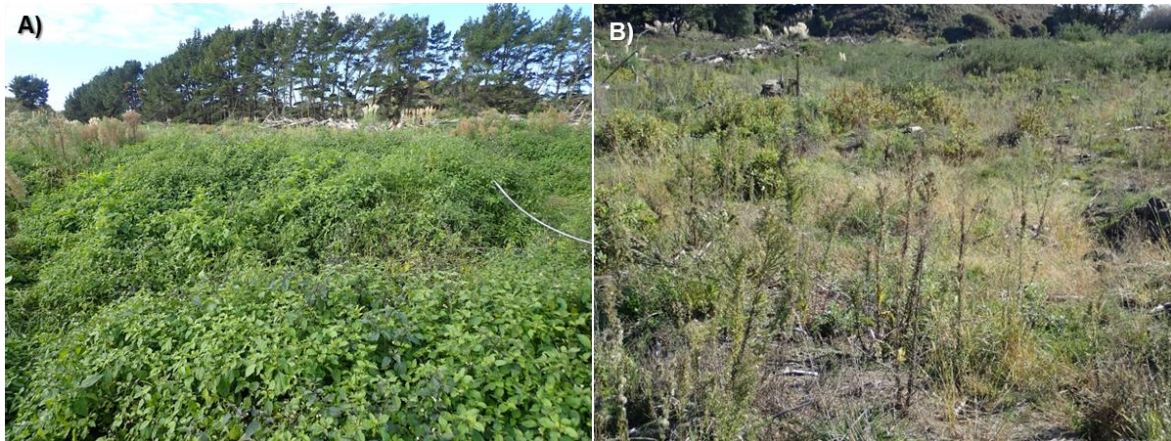
Figure 13 A) Overgrown part of the experimental plot; B) area planted in natives but non-irrigated, with fleabane.

During plant monitoring in May 2019 few natives were evident in the experimental plot due to the overgrowth of weeds (Figures 13A & B). Plant survival in the TMW irrigated plots with and without weed control was lower (27% and 2.2%, respectively) than in the non-irrigated plots (65%) (Figure 14A). Plant mortality in the non-irrigated treatment was comparable to other native restoration sites in NZ, where seedling mortality typically ranges from 11-38% in the first year (Anton et al., 2015). However, the lower plant survival in the TMW-irrigated areas was unlikely a direct consequence of irrigation, but rather a result of weed competition, which can significantly reduce native plant survival. There was an inverse relationship between native plant survival and weed coverage (Figure 14B). While other studies found belowground competition to be dominating interactions between invasive species and native seedlings (Costa et al., 2019), competition for water and nutrients is unlikely with irrigation of TMW. Instead, the effect of weeds on native plant survival likely resulted from the competition for light (Williams & West, 2000), as well as the high-humidity conditions created by TMW irrigation underneath a dense weed canopy.

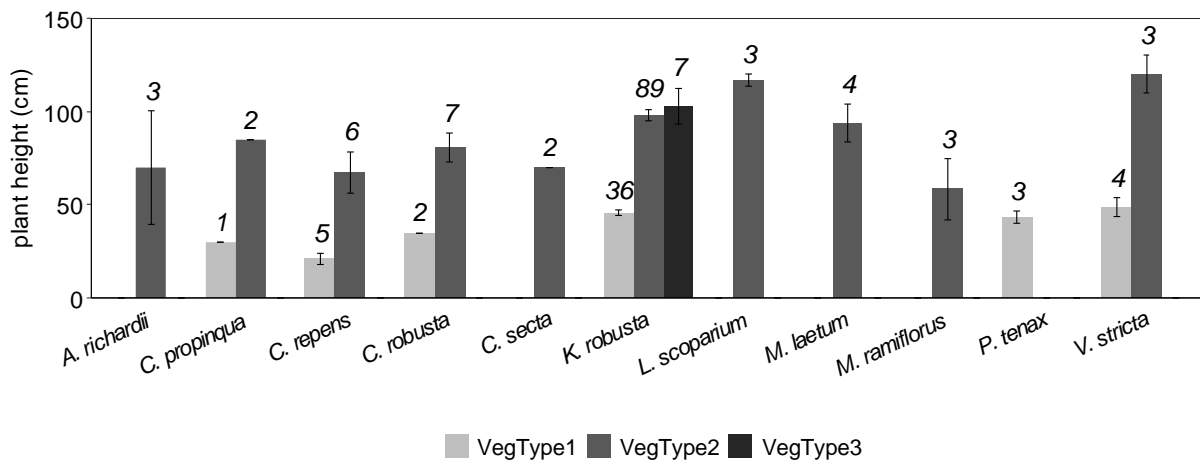
Figure 17 Plant height of individual native species in different vegetation management types (VegTypes) at The Pot in May 2019, approx. one year after planting. VegType1: non-irrigated, VegType2: irrigated with weed management, VegType3: irrigated without weed management. Values are means \pm standard errors, with n shown above error bars.

The height of the native plants differed between non-irrigated control and TMW irrigated plants (Figure 17). Plants were higher when they received TMW and weed management (VegType2) compared to a non-irrigated control (VegType1). Kānuka was the only species found in irrigated areas without weed control. Its average plant height was higher than the non-irrigated control. This was not unexpected, because kānuka is known to establish on disturbed sites as an early successional species (Aimers et al., 2021) and was planted at the highest percentage in this study.

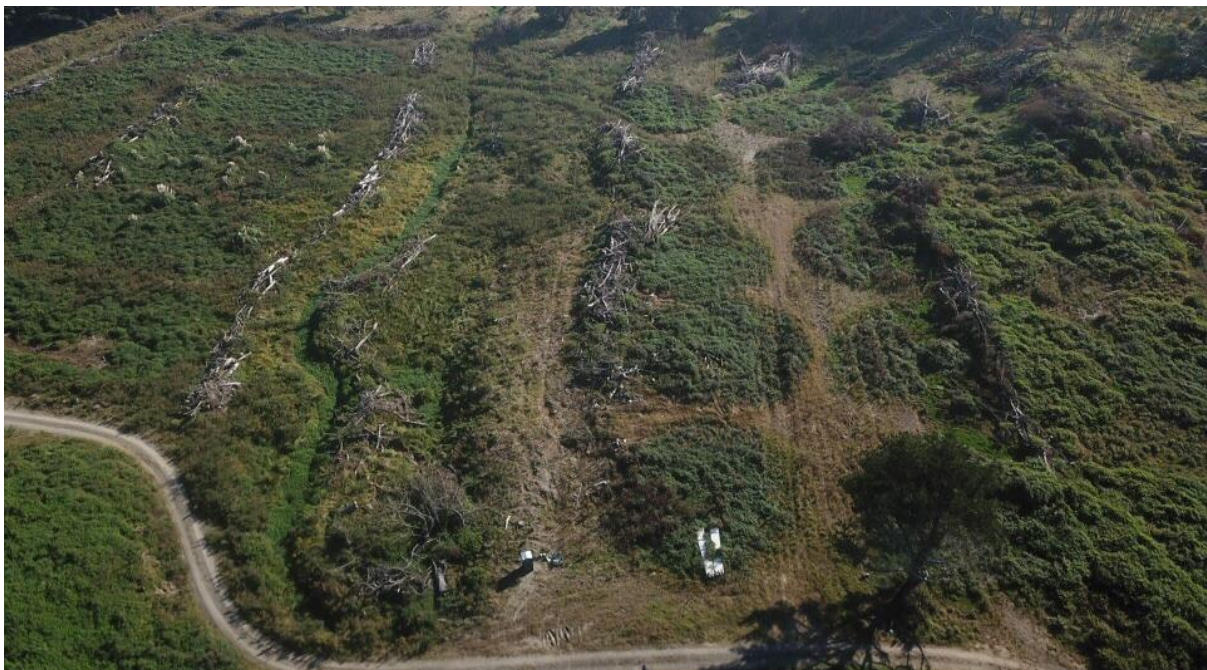
Figure 20 An aerial view of part of the experimental plot, showing the effect of the irrigation.

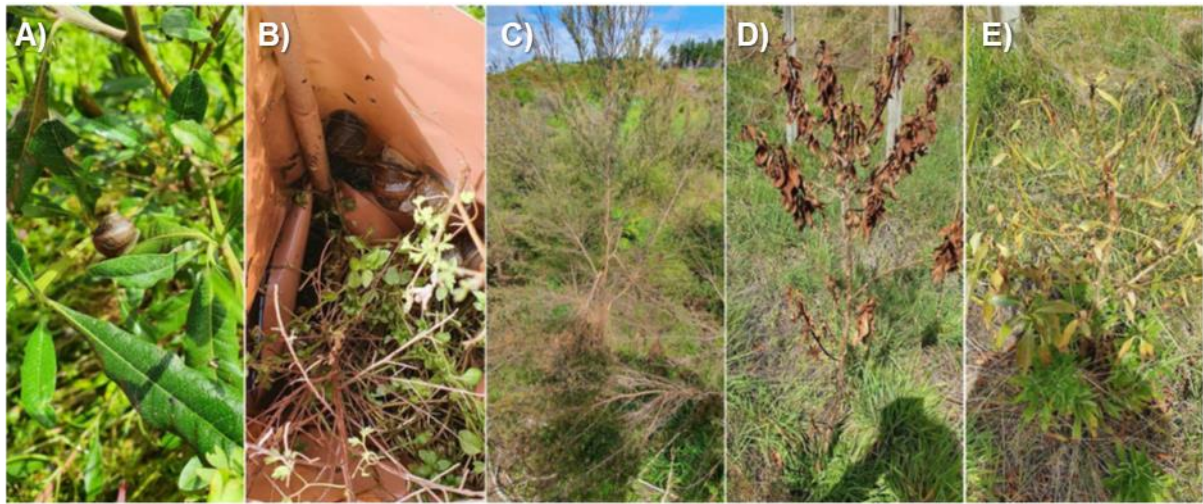
Figure 21 Damage to native plants caused by snails (A & B); browsing animals (C); and suspected pesticide drift (D & E). Note that D & E were in non-irrigated areas and adjacent to areas where herbicide had been used.

Throughout the site there was evidence of damage due to snails, browsing animals, and perhaps wayward herbicides used for weed control (Figure 21). The control of these factors will be crucial to minimise plant mortality. Early intervention will limit damage and reduce costs of lengthy management strategies and potential infill plantings that could otherwise become necessary.

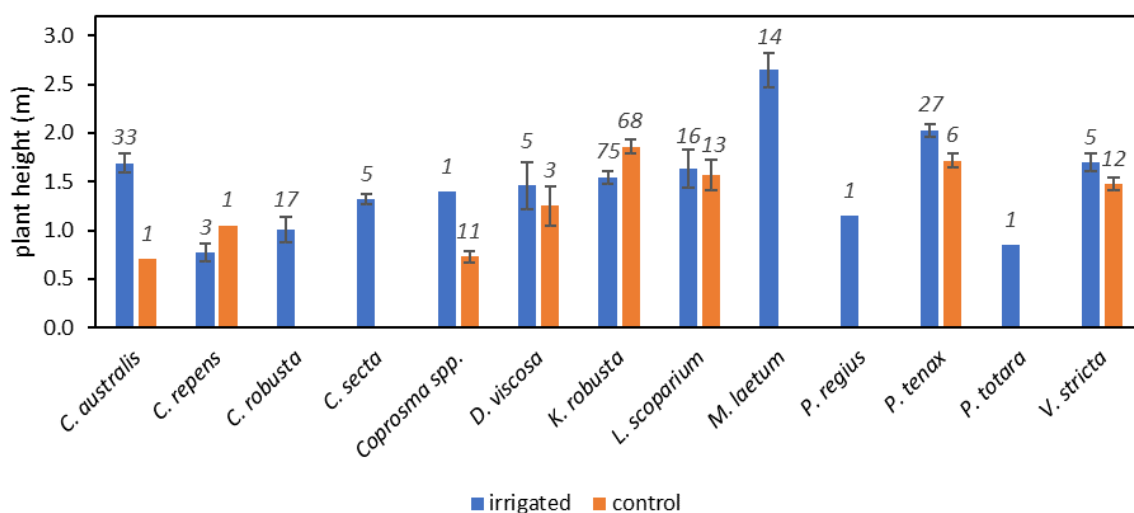
Figure 23 Plant height of NZ-native species in all irrigated transects combined, as well as in the non-irrigated control block next to the entrance. Mean ± standard error, with the italic number showing the number of plants recorded.

In the TMW-irrigated area, most of the native species significantly increased in height since 2021 (Figure 23). However, koromiko showed signs of chemical toxicity and did not increase in height. Similarly, akeake had brown lesions on the leaves, which could potentially indicate toxicity from TMW irrigation or spray drift (Figure 24). Karamu showed signs of animal browsing, with many specimens being defoliated, and did also not increase in height. With the exception of kānuka, plant heights in the control plots were the same or lower than in the TMW-irrigated plots. Therefore, over the four-year growing period, there is evidence that the TMW increased plant growth. This is consistent with another site where TMW irrigation accelerated the growth of New Zealand native vegetation (Meister et al., 2022). The most successful native species were New Zealand flax, ngaio, and cabbage tree.

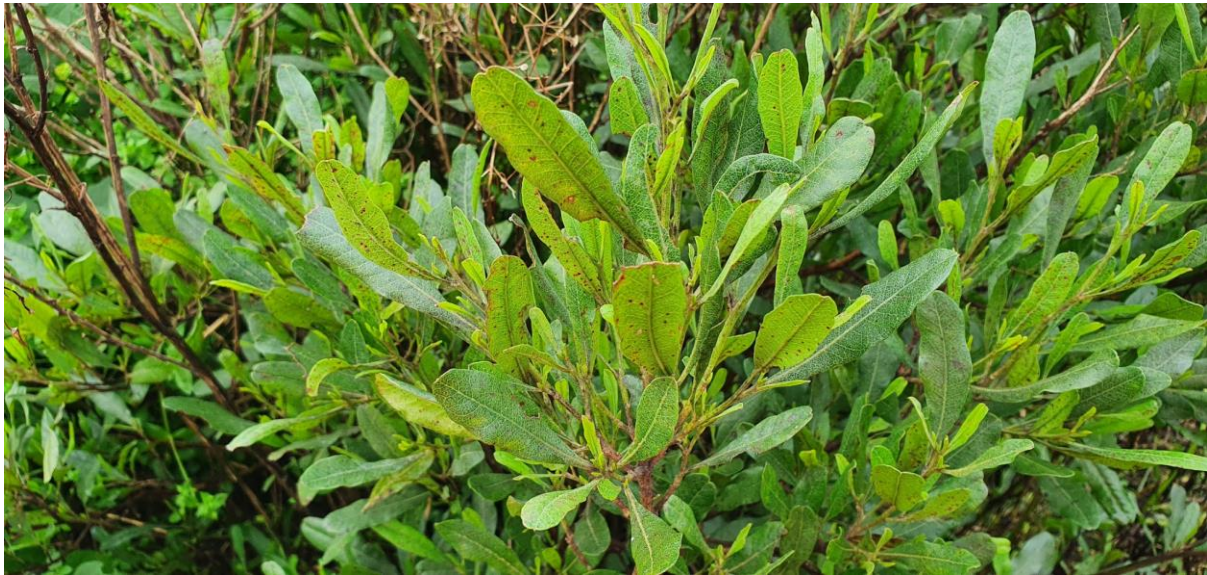
Figure 24 Evidence of toxicity in akeake.

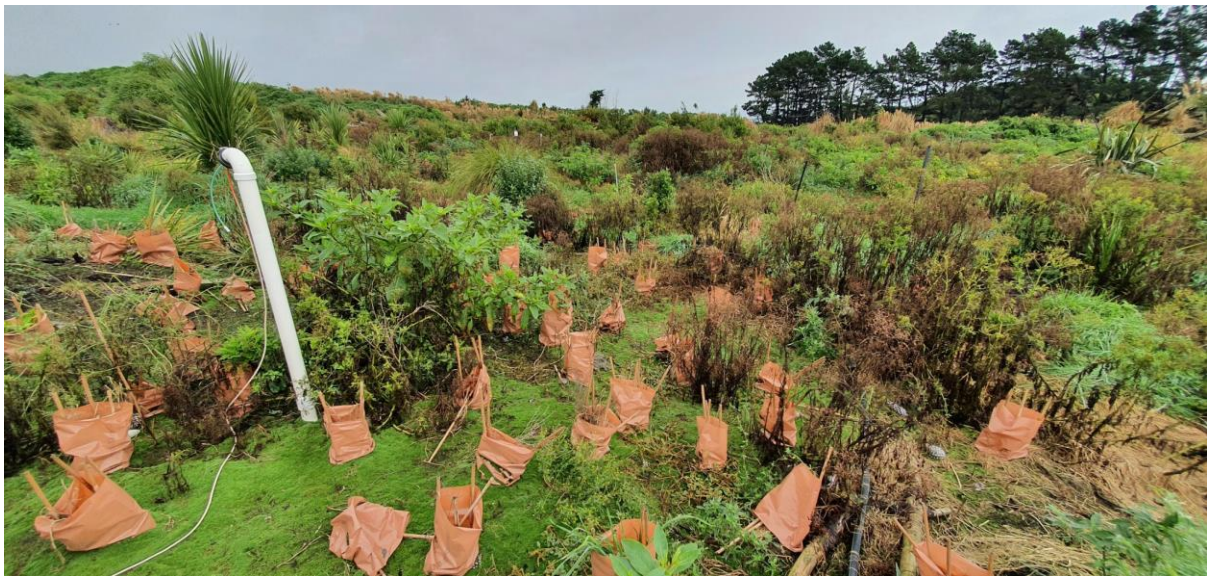
Figure 27: All kānuka and other higher plants on two of the lysimeters had died, leaving a cover of moss.

Samples from the sampling campaign conducted between November 2021 and January 2022 were sent for analysis of nitrate and ammonium. Generally, the mass of nitrate leached was small, representing about 2-20% of the mass of nitrogen applied. This was most likely due to groundwater ingress that led to a dilution of the leachate within the lysimeter, and possibly due to some denitrification. However, denitrification in TMW-irrigated soils was reported to contribute just 1% to N losses from TMW-irrigated soils (Van der Weerden et al., 2016). It was evident that the lysimeters had become flooded due to nearby surface ponding. There were no surviving kānuka on two of the lysimeters (Figure 27), and consequently no roots to impede infiltration. All higher plants at these sites were dead, presumably due to chemical toxicity arising from excessive TMW irrigation.

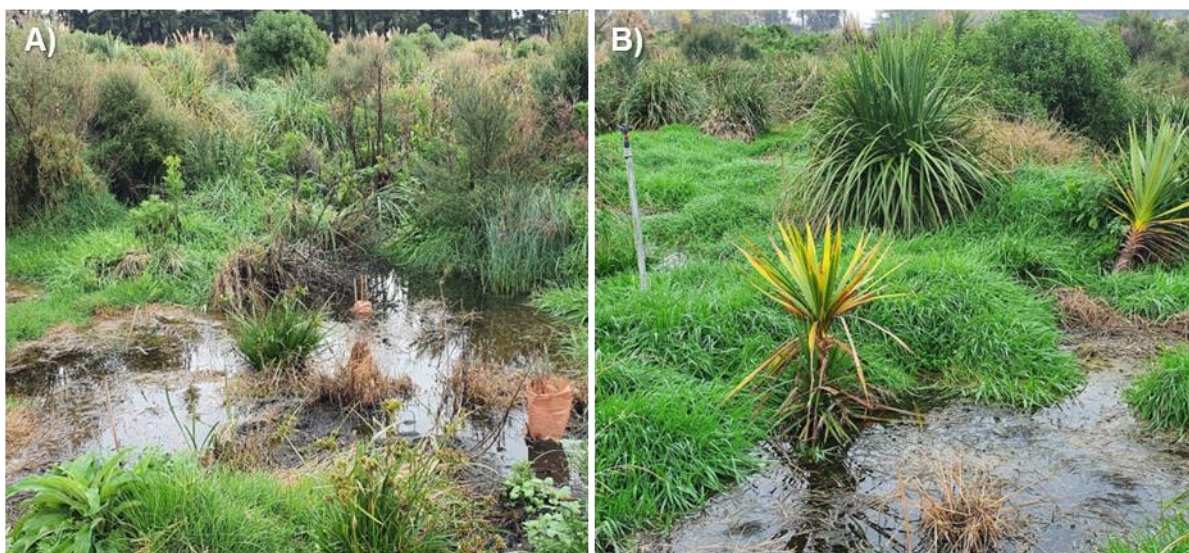
Figure 29 A) Standing water in the TMW-irrigated plots; B) cabbage trees starting to die off in May 2022.

The changes in the weed flora are consistent with observations of extremely wet conditions at the site. The fern species and pampas grasses mostly occur in wet conditions (Gosling et al., 2000; Lehmann et al., 2002). Standing water was present in various locations across the experimental plots at The Pot (Figure 29A & B). In many of these areas, all higher plants had died, including both weeds and NZ-native plants, which was a likely a consequence of either the waterlogged conditions which plants were not selected for, or chemical toxicity arising from high application rates of TMW (Figure 30A). Toxicity can derive from excess nutrients or increased sodicity and salinity, for example (Bernstein, 1975; Chaney, 1989). Some areas around the sprinklers were only covered in pasture and could not sustain other plant species (Figure 30B). In contrast, native plants were more present outside of the irrigated areas. In order to avoid further plant death, a reduction in TMW application will likely be required. It was demonstrated elsewhere that native vegetation can be established successfully with TMW irrigation of 1000 mm/yr (Meister et al., 2022). If this was achieved, native plantings at The Pot would be highly valuable as they provide ecosystem services, for example carbon sequestration and erosion control, provide a habitat for native insects and birds, and may be utilised for the production of fibre and timber (Gutierrez-Gines et al., 2022).

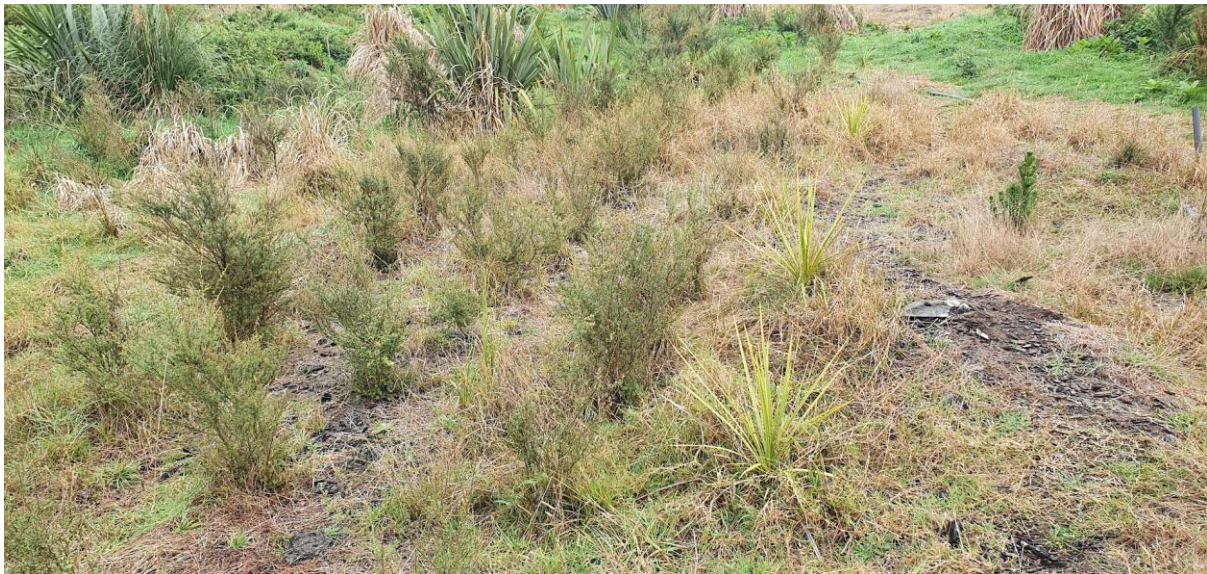
Figure 31 Non-irrigated areas where native plants are not growing well in May 2022.

In some areas that were not water-logged and received little or no irrigation, NZ-native plants were alive but appeared to have not grown and their size was lower than what would be expected for the plants' age (Figure 31). This indicates that it is unlikely a closed canopy of native plants will establish there. It should be noted that in some of these areas there were no pines (before harvesting) and scant weed cover. In these areas, another growth limiting factor is evident. It is possible that these areas were previously used for skid sites. Tree growth is often impaired at skid sites due to the area being stripped of topsoil and compacted (Hall,

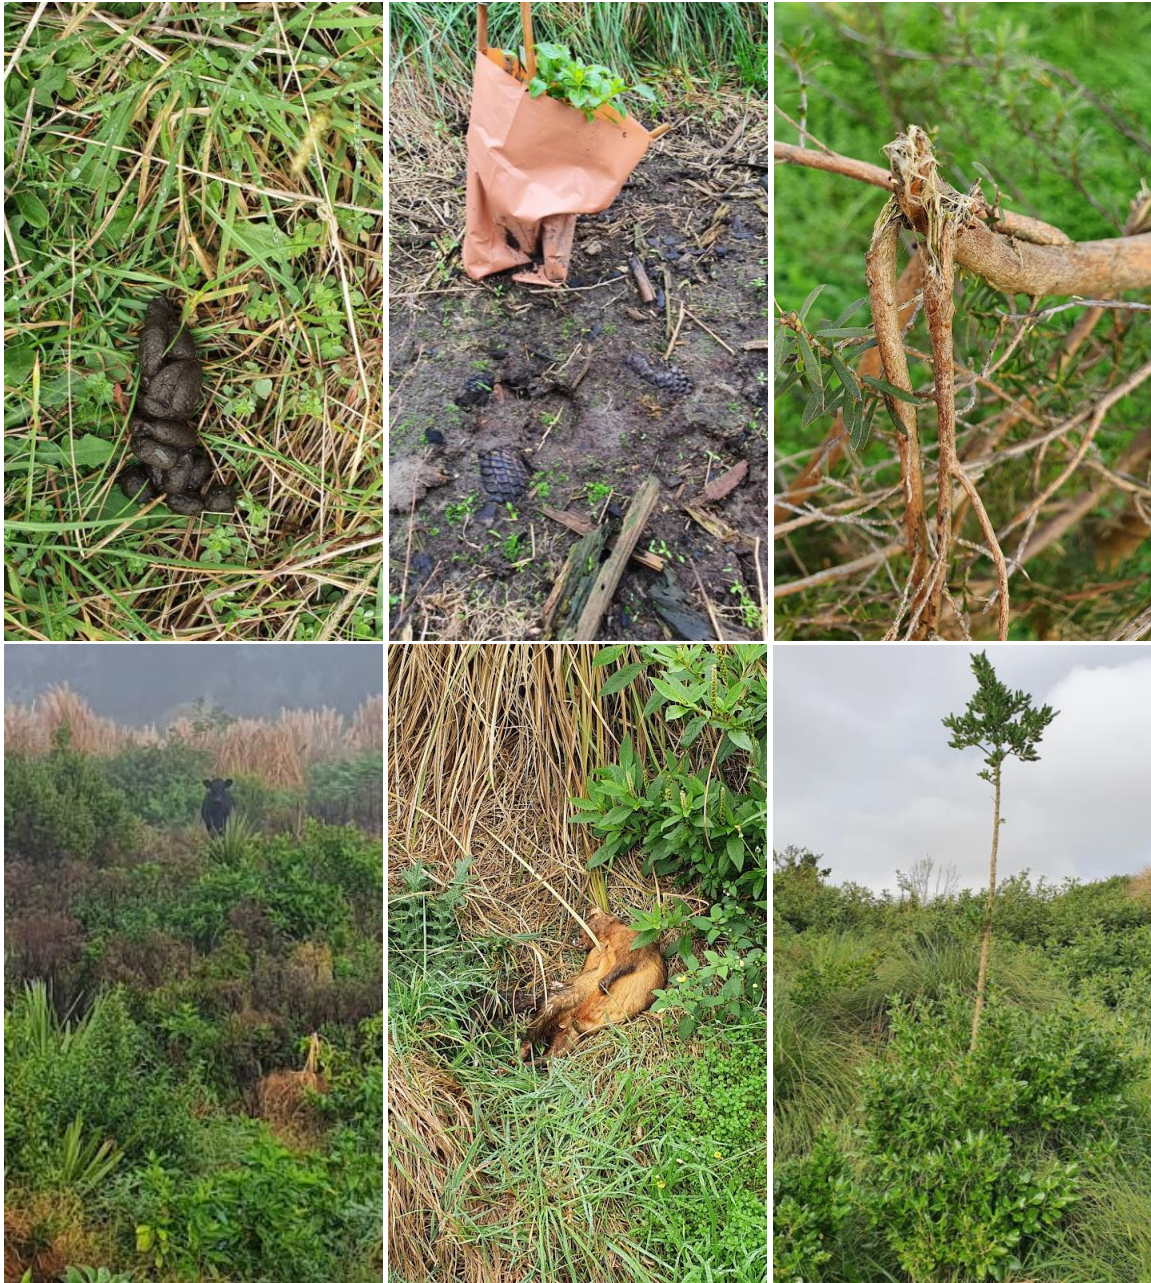
Figure 32 Evidence of animals browsing and damaging plants at The Pot.

Throughout the site, there was evidence of animals impairing plant growth in May 2022. Droppings of deer and cows were distributed throughout the plots, and a cow was spotted on site (Figure 32). In addition, snails were present at the site, which were also observed in 2021. We observed plant damage that was consistent with animal browsing and scratching, including defoliation and broken branches (Figure 33). Fencing and lethal methods of pest control, including shooting and poisoning, may be required to control pests at the site. Where large populations of mammal pests are present, this can lead to the disappearance of palatable, typically large-leaved, species from native plantings (Bee et al., 2007; Smale et al., 1995). This is supported by observations at The Pot, where many *Coprosma* spp. appeared to be defoliated due to browsing (Figure 33).
