Foxton Wastewater Land Treatment

Consenting and Construction Challenges and Lessons

Phil Lake

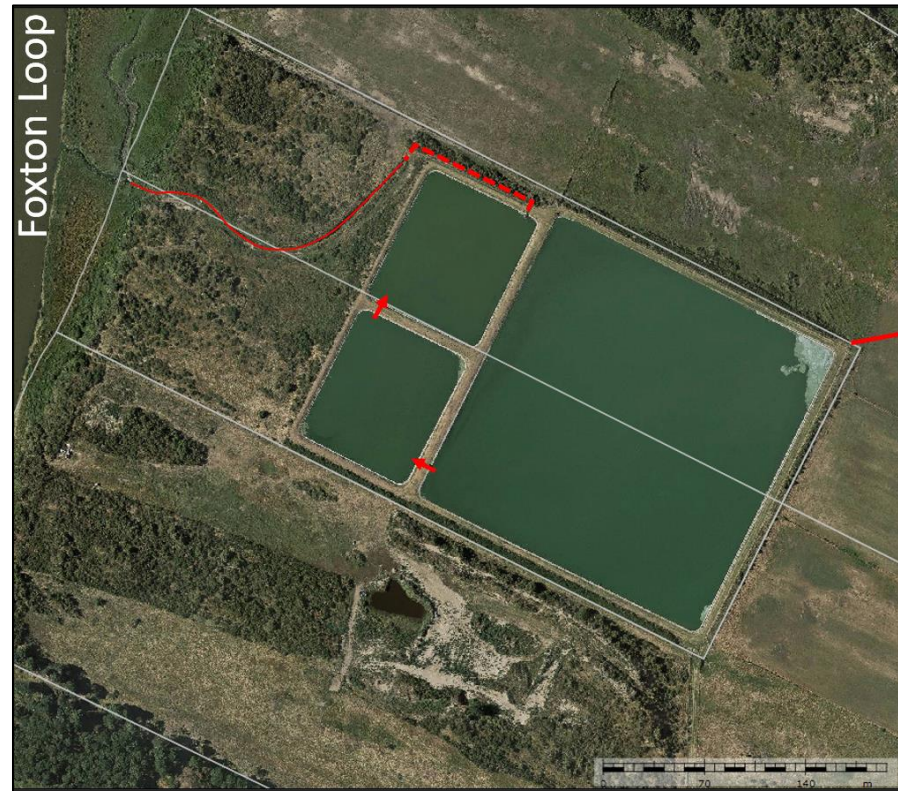
- WWTP (single pond) built at Matararapa in 1976.
- Two maturation ponds added in 1993/94.
- Continuous discharges into Foxton Loop 3 km downstream of Foxton.

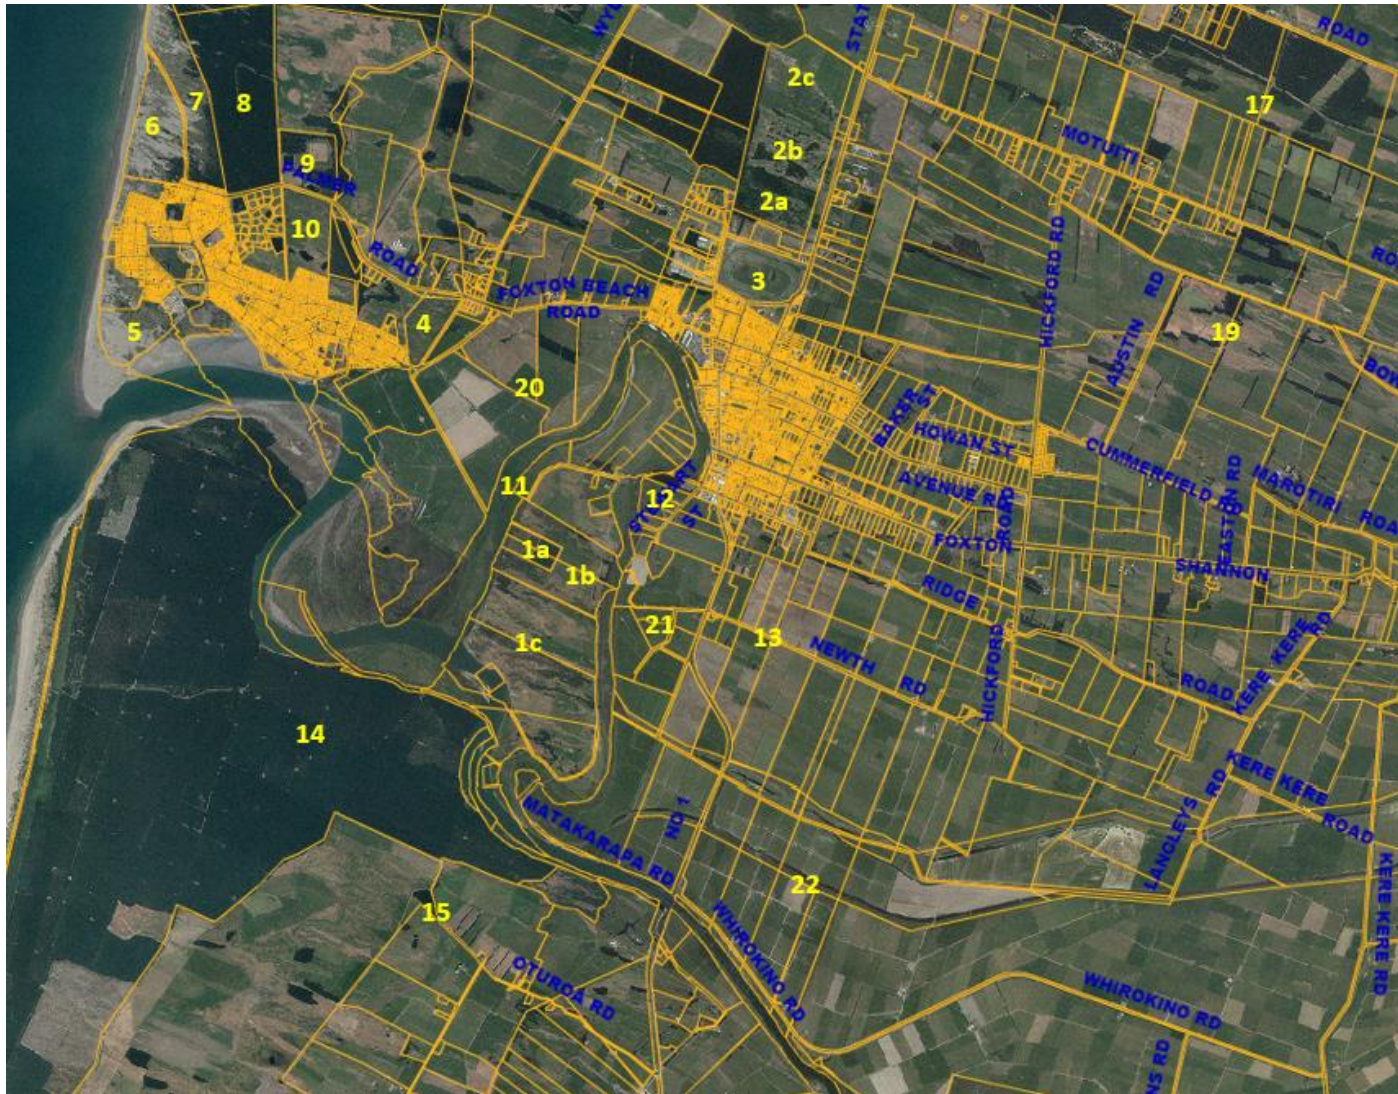
- Discharge Consenting – Site Selection
 - Focus Group consultation during 2014 included:
 - Identification of the community's core values and aspirations;
 - High level identification and consideration of 22+ locations;
 - Desk-top feasibility studies of some potential discharge sites;
 - Refinement of preferred discharge site locations and costs;
 - Consideration of land discharge regimes and design concepts.
 - Based on Focus Group outcomes and feasibility studies, Matarapa was selected as the best site in the area.

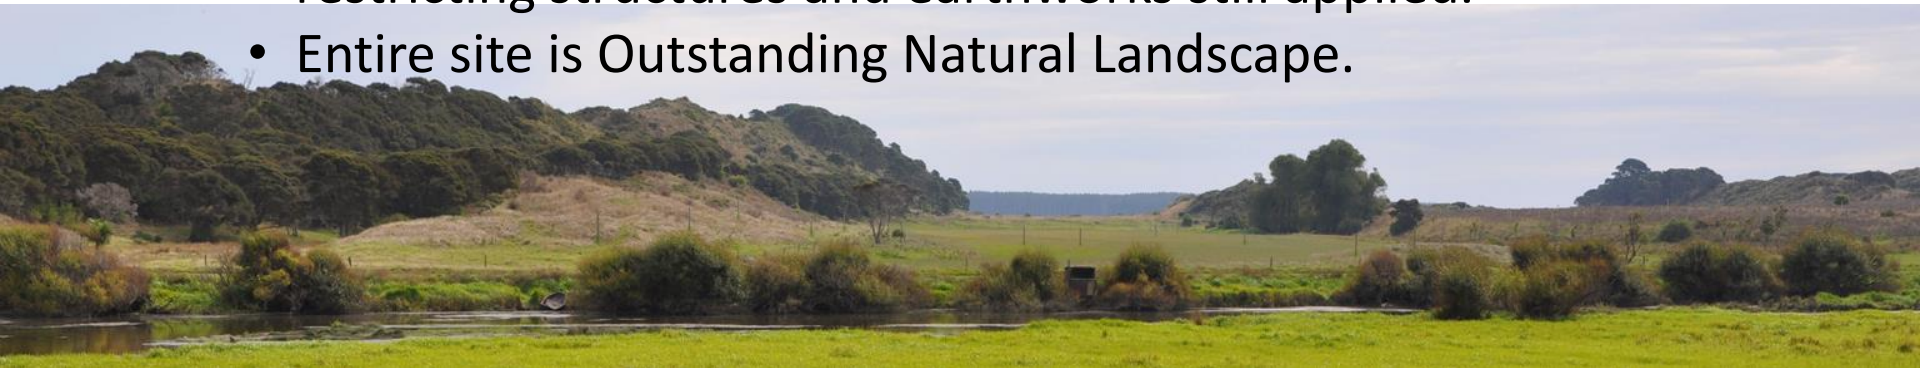
- District Plan constraints:
 - District Plan maps of flood hazard are incorrect but rules restricting structures and earthworks still applied.
 - Entire site is Outstanding Natural Landscape.

- Unable to modify terrain from original contours;
- All irrigation posts needed to be under 3 m high;
- Considered visual effects of fenceposts and irrigation posts;
- Considered visual effects of greening of pasture from irrigation;
- No rules specific to kanuka but trees needed to be protected.
