Report 2: A Quantitative Assessment of Sludge in the Lower North Island

October 2017

Regional Biosolids Strategy – Lower North Island

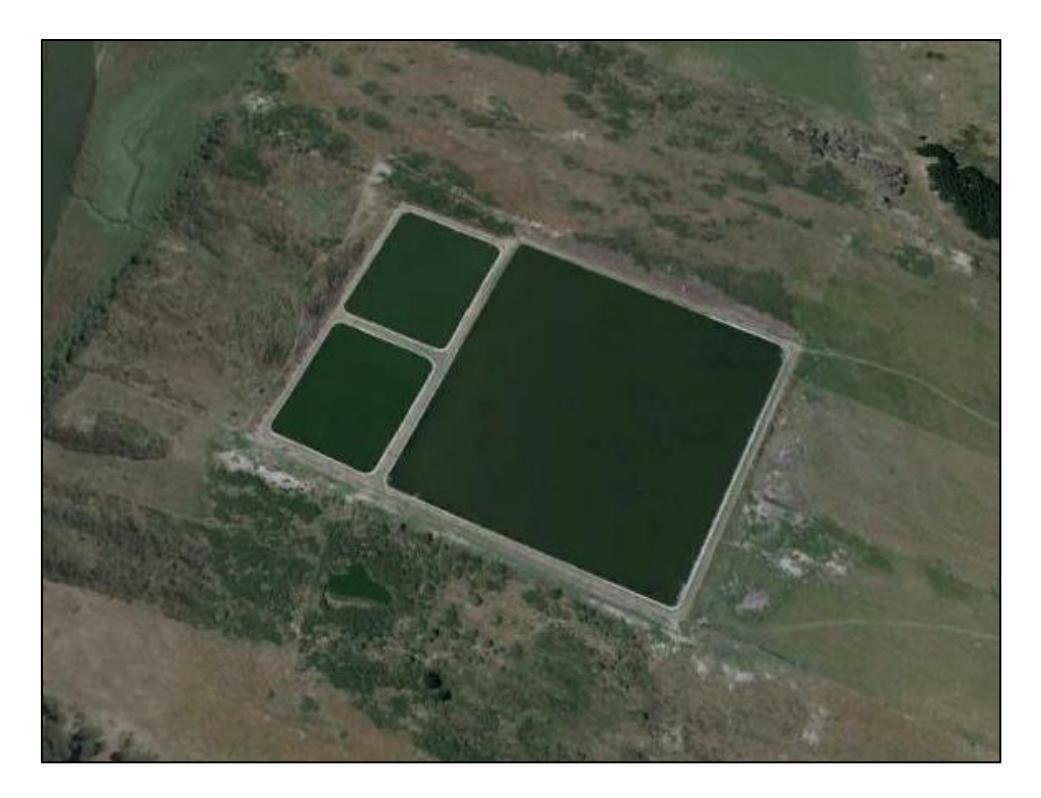
Figure 3.1: Aerial Image of Foxton WWTP Oxidation Ponds

The layout of the Foxton WWTP oxidation ponds is shown in Figure 3.1.

Foxton WWTP is situated at Matakarapa, a few km south-west of Foxton, and serves a population of around 2,500 with some trade waste contribution. There are three naturally aerated (i.e. no mechanical aeration assistance) oxidation ponds in series that have been accumulating sludge since their construction (1975 for the main pond and 1997 for the two smaller maturation ponds) and are scheduled for de-sludging in the next 12-18 months.

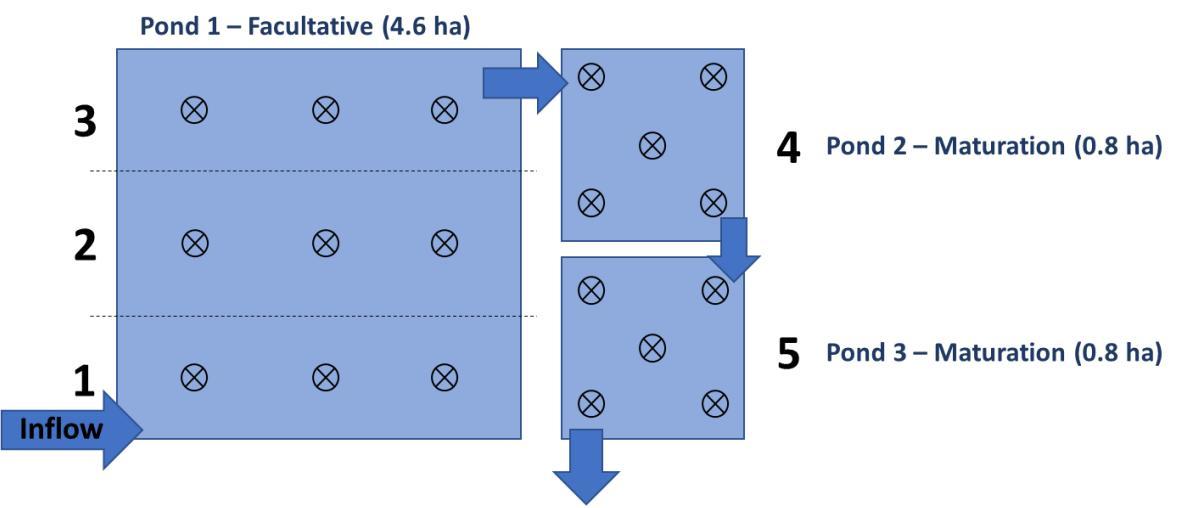
Figure 3.2: Diagram of Foxton oxidation ponds showing the locations of composite samples taken

The locations of the sludge samples taken are shown in Figure 3.2. Five composite samples of sludge were collected for analysis to serve as representative samples for the ponds. These were obtained by taking sub samples using a tube sampling device as follows (Figure 3.2). Pond one (Facultative) was divided into three sections representing distance from inflow. Three sub-samples were taken from each section to combine as one composite for each; Foxton 1, 2 and 3. Five subsamples were taken from each of the two smaller ponds (maturation ponds 2 and 3) and combined for each pond to give samples Foxton 4 and 5.

- The Foxton 4 sludge sample was collected from the second oxidation pond in the series where it has been observed that there is sludge carry over from the first pond. This may have contributed to the elevated organic matter, ammonia and metal concentrations.

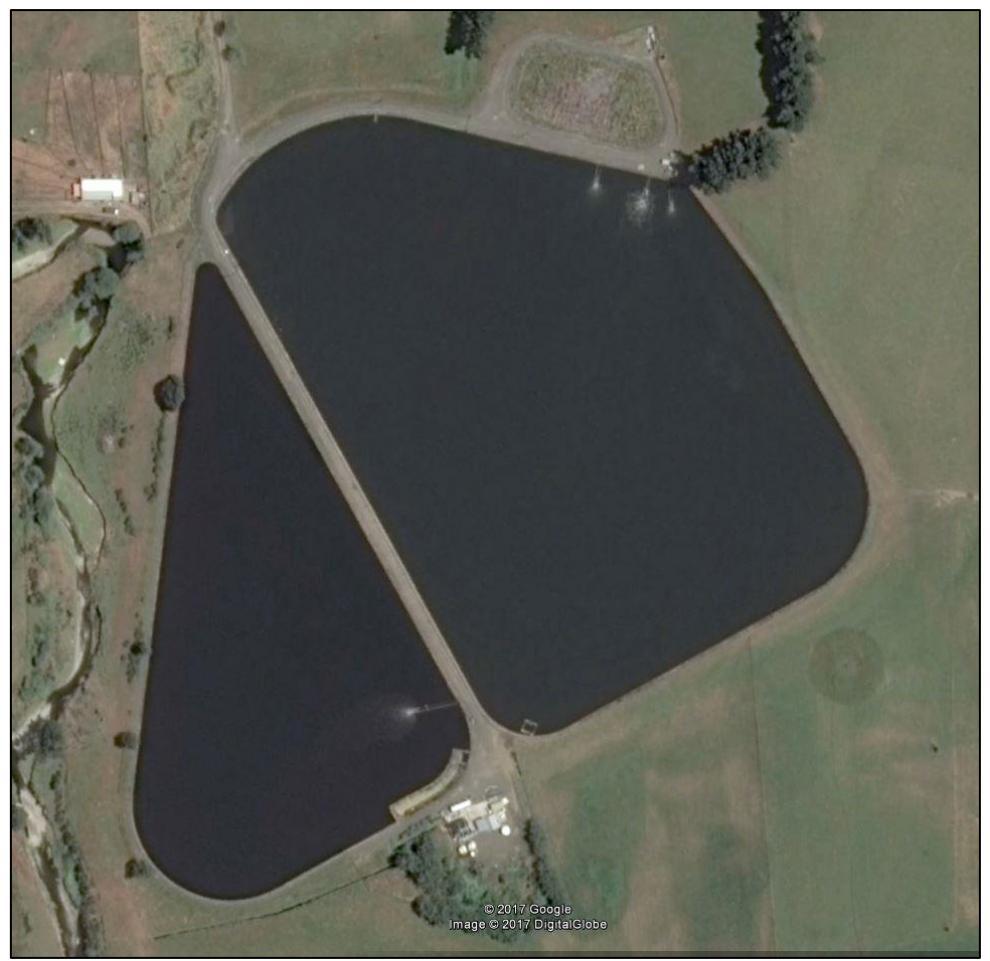
Figure 3.4: Aerial Image of Marton WWTP

The layout of the oxidation ponds at Marton WWTP can be seen in Figure 3.4 (the anaerobic lagoon occupies the vegetated oval area at the top of this image).

The oxidation ponds have never been emptied since they were constructed in the 1970's and there is no information available on sludge quantity or quality. The characteristics of the sludge in the ponds is likely to be highly variable with depth and distance from the inlet. Variations of trade waste production will also contribute to the highly variable nature of the sludge. Based on this, a multiple grab sample and subsequent composite sample schedule of sampling was determined to be most appropriate to obtain representative sludge samples from the ponds.

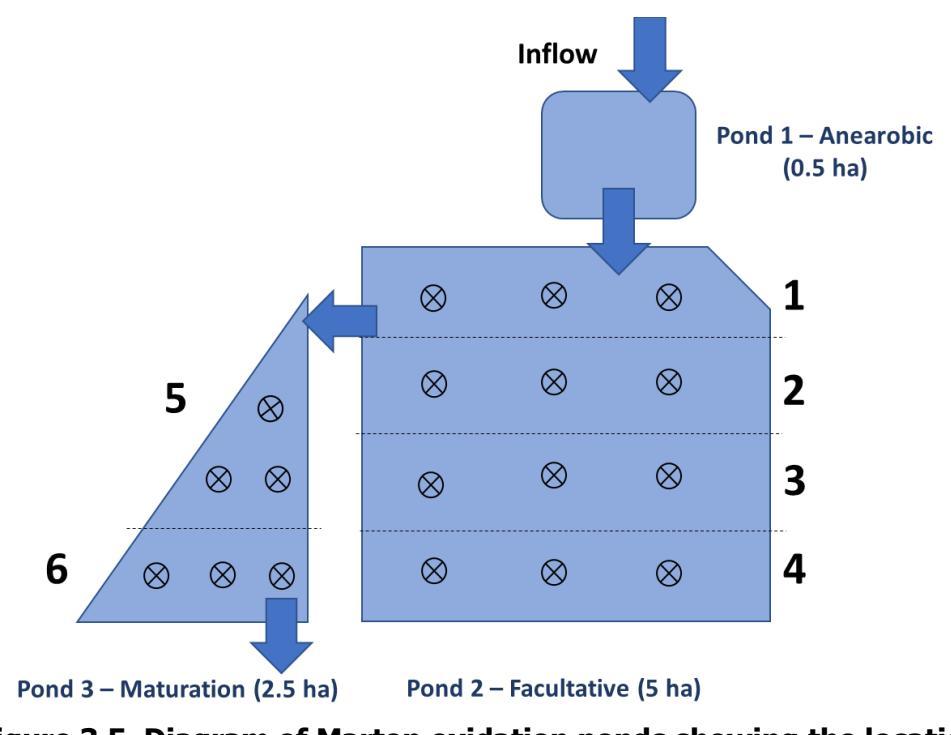
Figure 3.5. Diagram of Marton oxidation ponds showing the locations of composite samples taken

The locations of the sludge samples taken are shown in Figure 3.5. Six composite samples of sludge were taken for analysis to serve as representative samples for the ponds, these were obtained by taking sub samples using a tube sampling device inserted into the sludge (Figure 3.5). Pond 1 (aerobic lagoon) was divided into four sections representing potential movement of waste from inflow. Three samples were taken from each section to combine as one composite for each; Marton 1, 2, 3 and 4. Pond two (maturation) was divided into two sections and three subsamples taken from each and combined to give two composite samples; Marton 5 and 6.

- It is noted that a number of the parameters measured were different in Marton sample 6 compared to the other five samples. It is likely this is due to sampling zone 6 being the furthest from the WWTP inlet. The scientist sampling this pond noted that there was little sludge in this zoneand samples consisted of some sediment from the pond base.

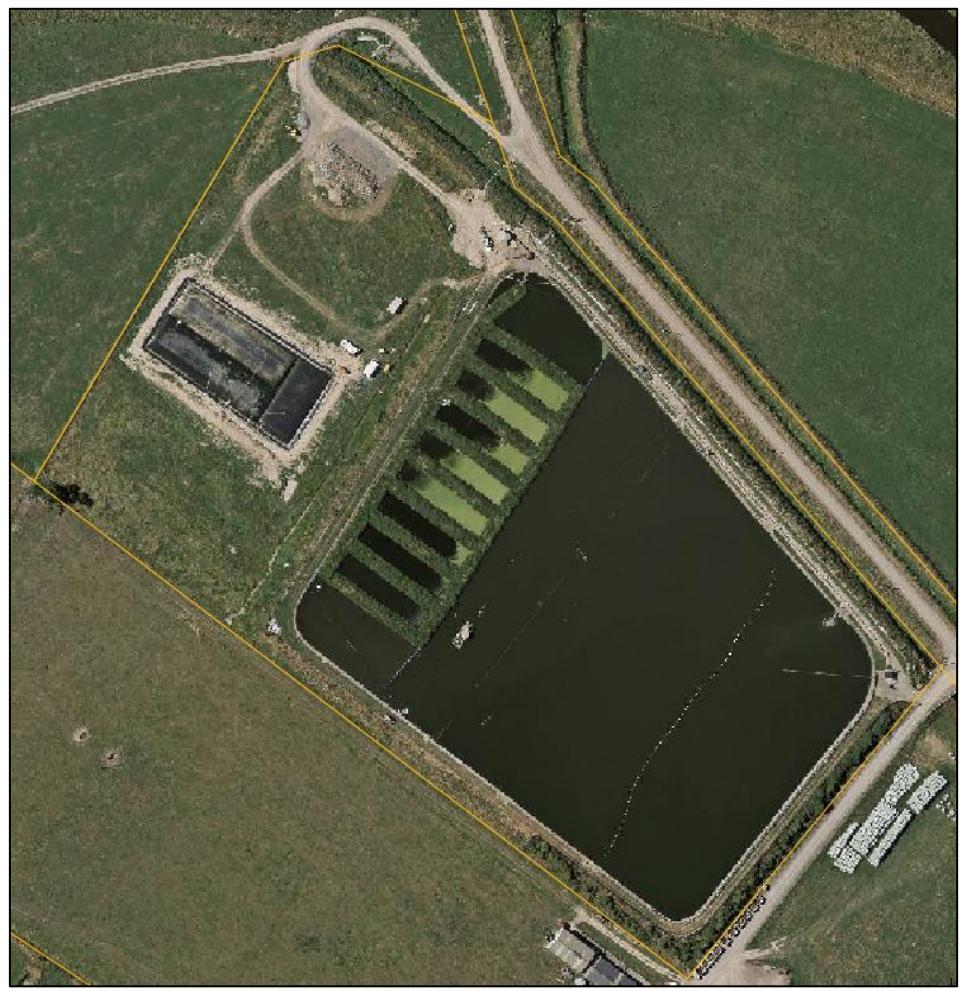
Figure 3.6: Shannon WWTP and geobags of sludge (upper left)

The Shannon WWTP serves a population of around 1,500 and has one oxidation pond with a floating wetland. The oxidation pond was de-sludged in November 2015 when sludge was transferred to three geo-bags on site for dewatering/storage. Sludge remains in geobags and is due for transfer to landfill. The WWTP and full geobags are shown in Figure 3.6.

The current volumes of sludge stored at Shannon and Tokomaru were estimated from the approximate dimensions of the geobags. Their heights were estimated based on photos and sampling staff observations, while their lengths and widths were measured from recent aerial photography that is publicly available via internet on Google Earth and Horowhenua District Council's on-line maps (as shown in Figures 3.6 and 3.7 above).

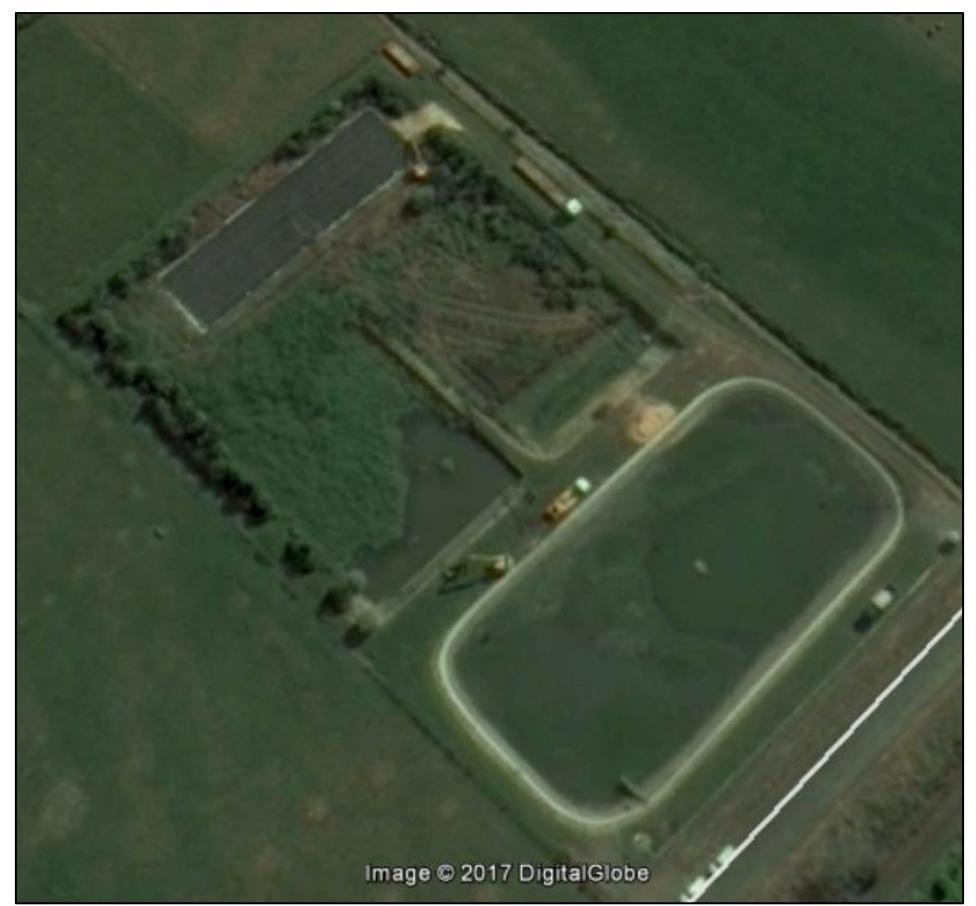
Figure 3.7: Tokomaru WWTP and geobag for sludge (top left)

Tokomaru WWTP serves a population of 552 and has one oxidation pond which discharges wastewater to onsite wetlands. The oxidation pond was de-sludged in April 2016 when sludge was transferred to one geo-bag for dewatering until eventual disposal at landfill. The WWTP and geobag (prior to de-sludging commencing) are shown in Figure 3.7.
