Lake Coleridge – 20 Years On

Brian Ellwood – Lowe Environmental Impact

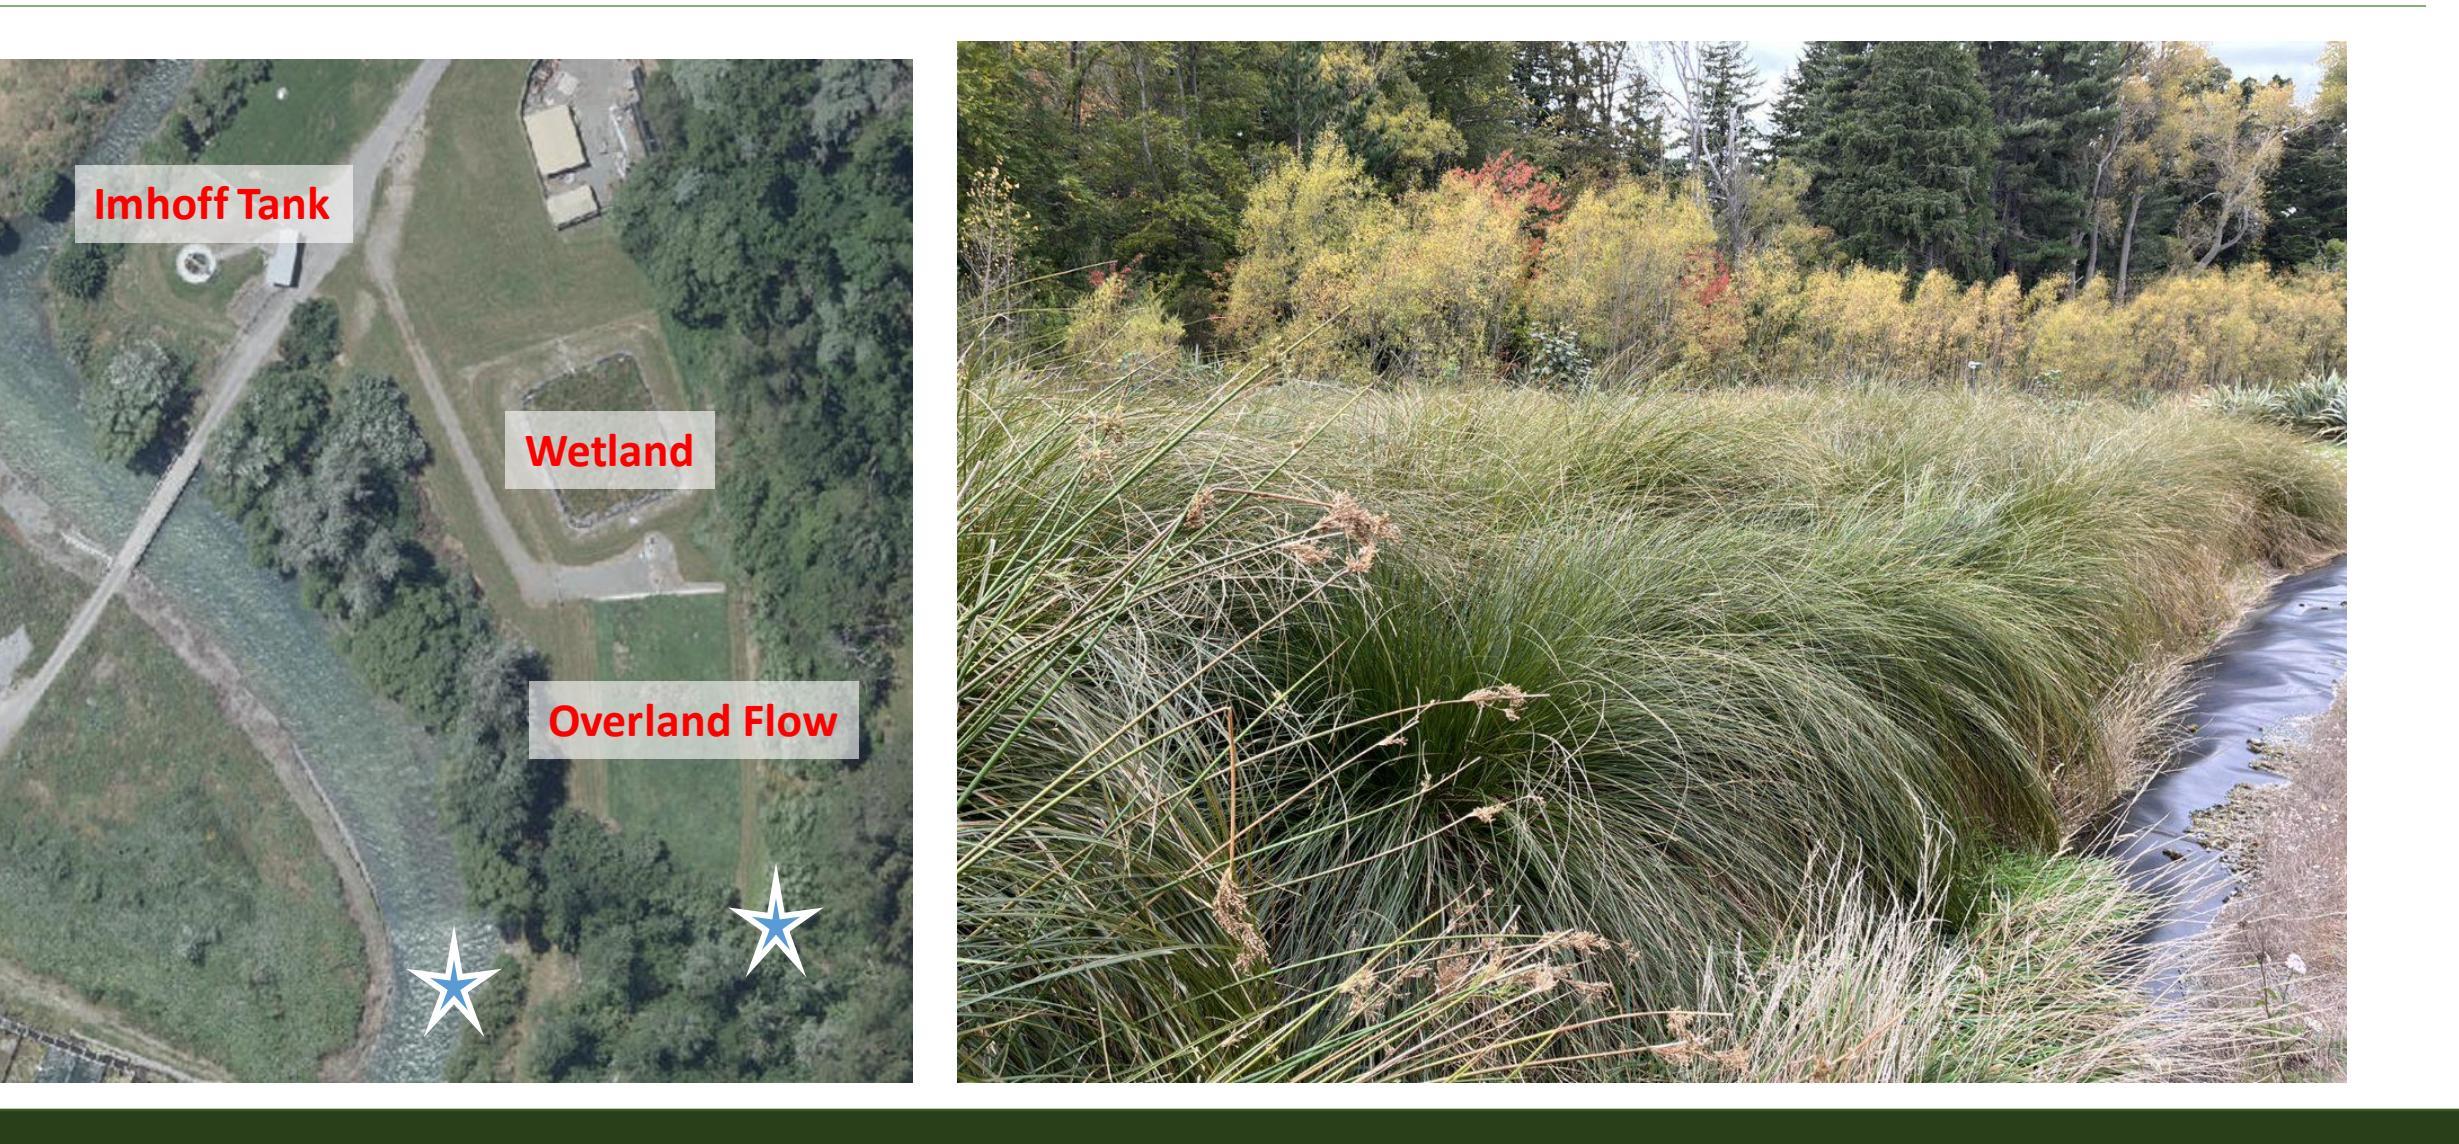
Subsurface Wetland

- Submerged vegetated bed wetland: 31m long, 16m wide
- Surface area: 500m²
- Working depth: 0.55m
- Design flow: 41 m3/day
- Hydraulic retention time: approx. 2 days
- Planted with: Carex Secta & Carex Virgata
- Achieving: low BOD, SS and nitrate
- Low maintenance

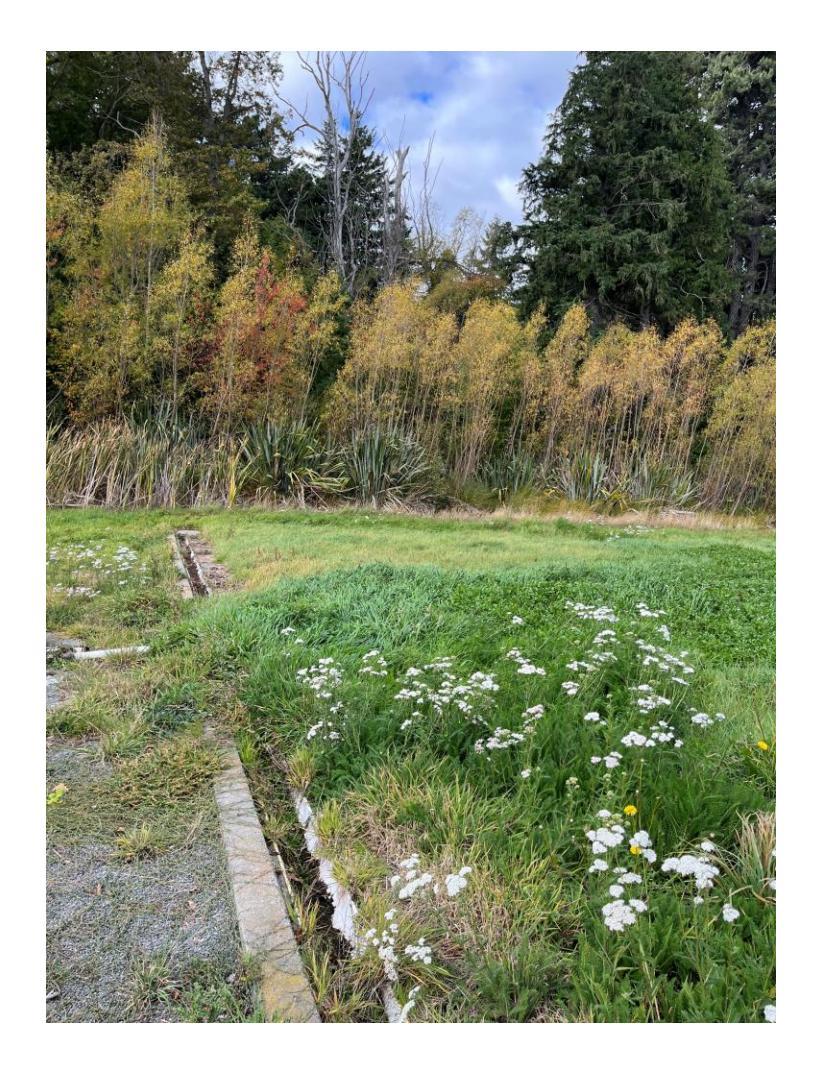
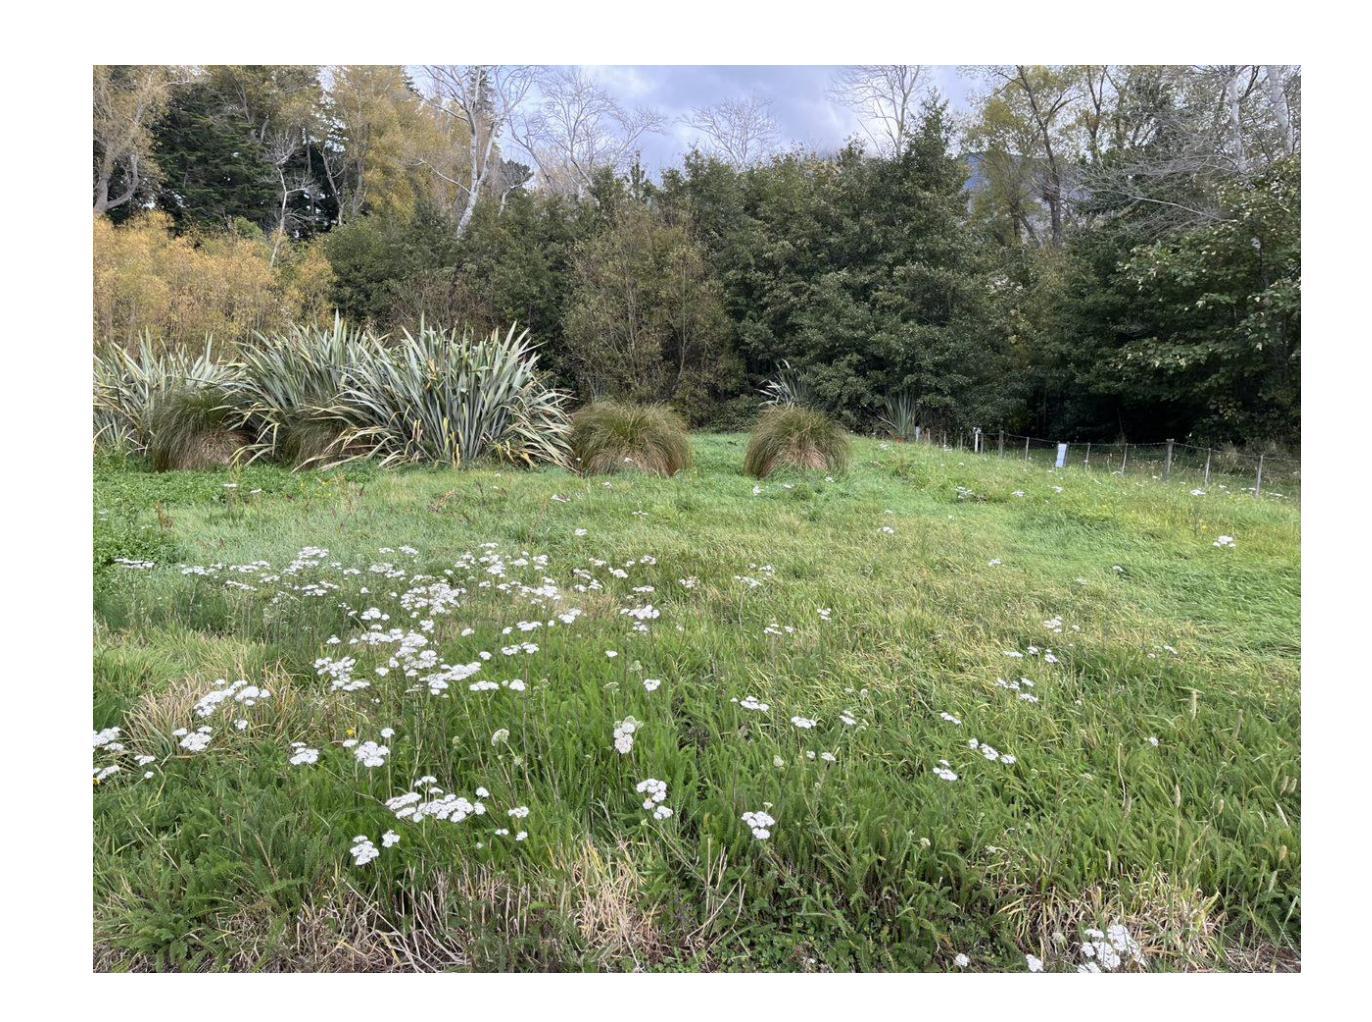
Overland Flow Area – Pre-Upgrade

- Water quality outcomes have consistency been achieved,
- However not all consent conditions were being met
- Overland flow area degraded:
 - Water unevenly distributed
 - Channelling of flow across overland flow area
 - Ponding of water

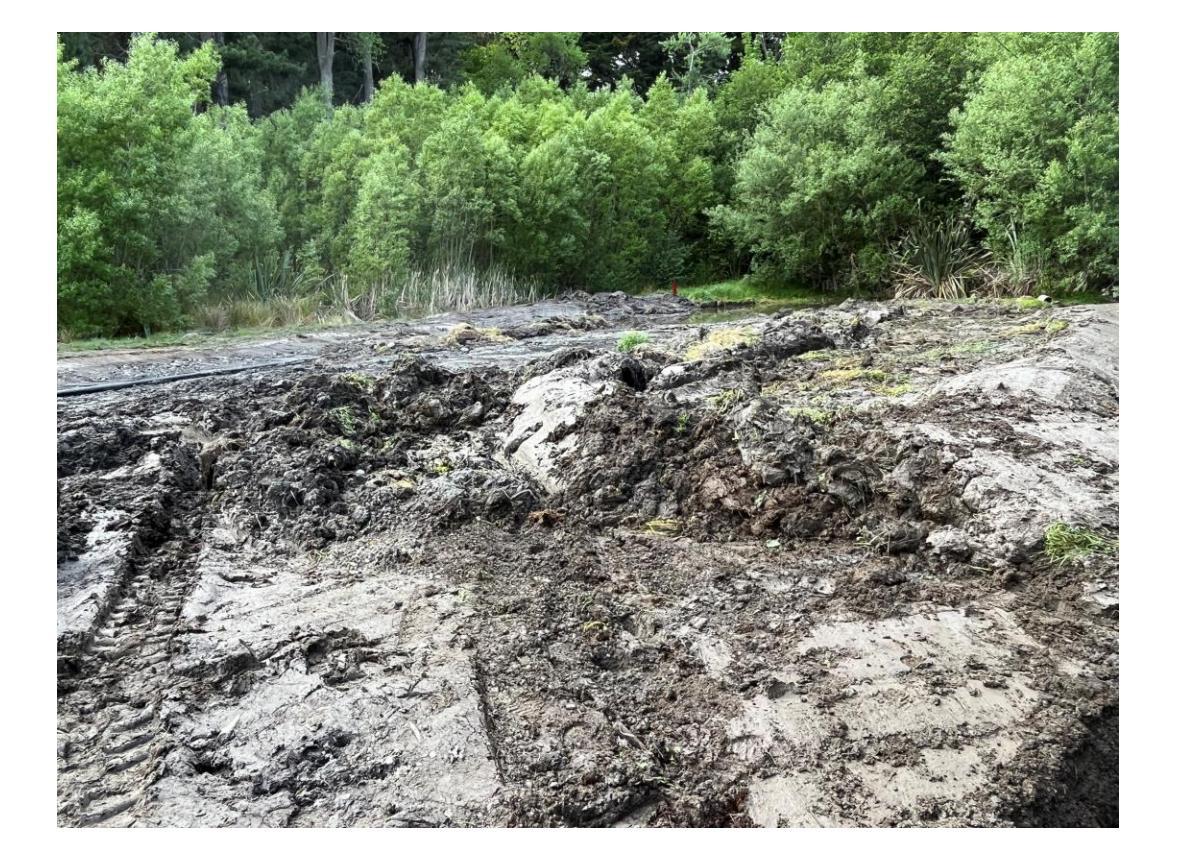
Field inlet

• Field vegetation removal and releveling

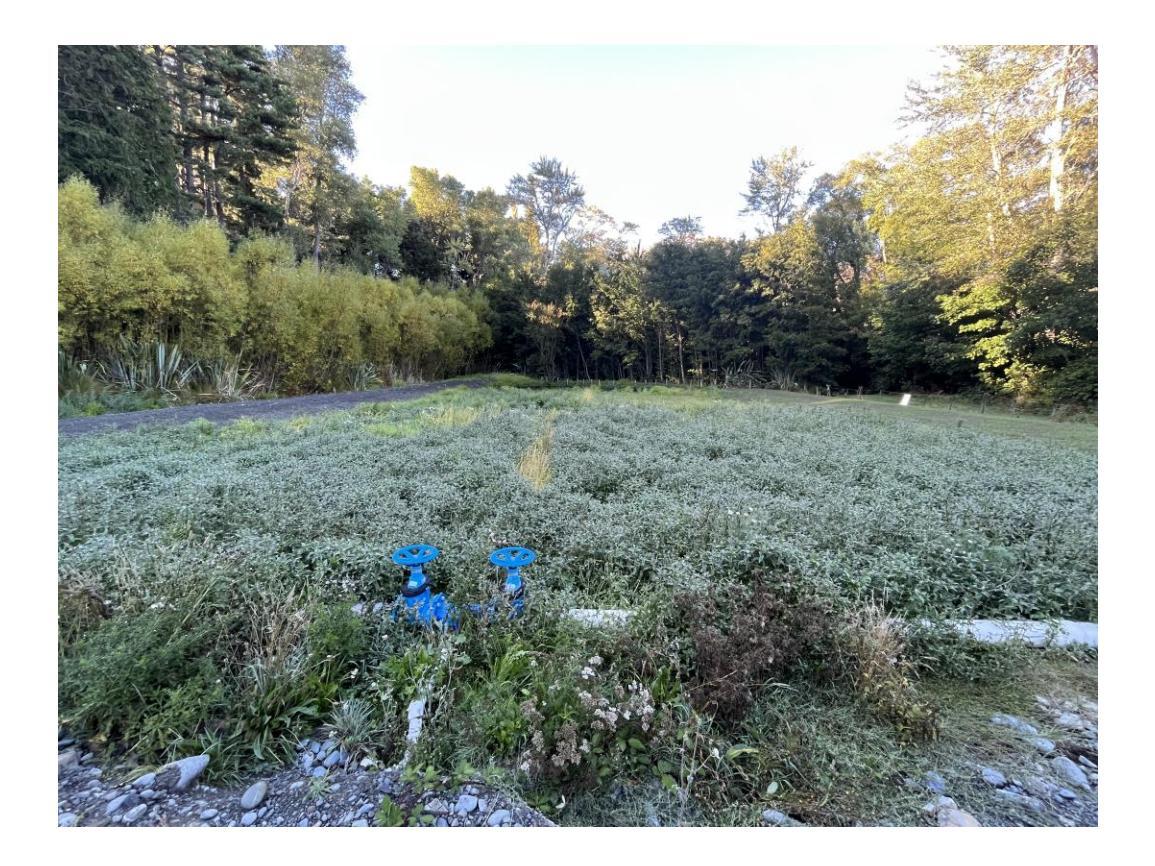
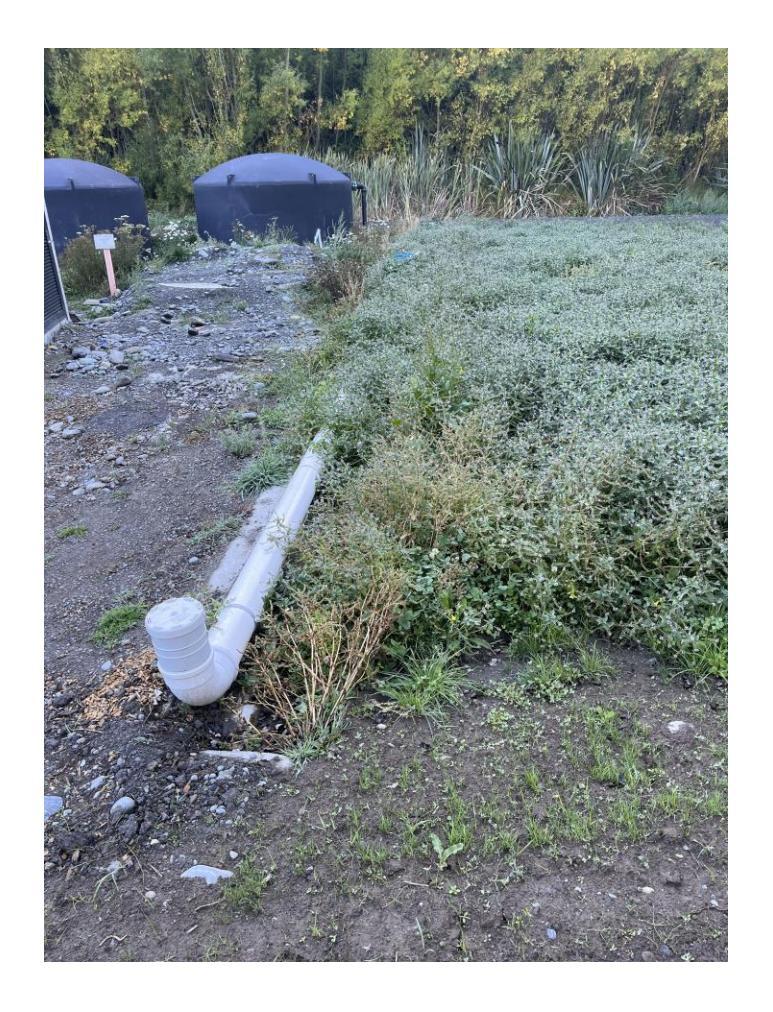
• Upgrade inlet manifold

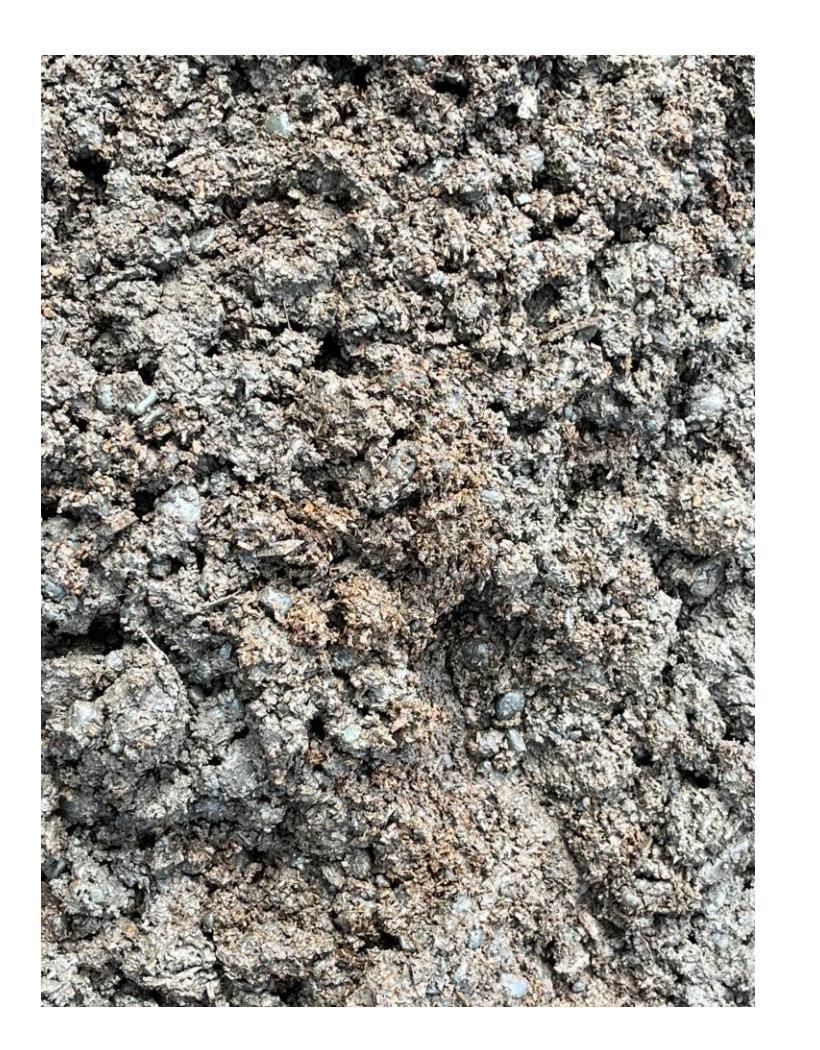
Denitrification Trench Testing

- Existing denitrification trench: sawdust/gravel blend
- Some sawdust still visible, similar to topsoil in Carbon and Nitrogen levels
- Lab analysis showed:
 - C:N ratio range: 15:1 to 22:1
 - High levels of potentially available nitrogen equivalent to 200 kg/N/ha
